Evaluation of New Home Energy Efficiency

An assessment of the 1996 Fort Collins residential energy code and benchmark study of design, construction and performance for homes built between 1994 and 1999.

Summary Report

June 2002

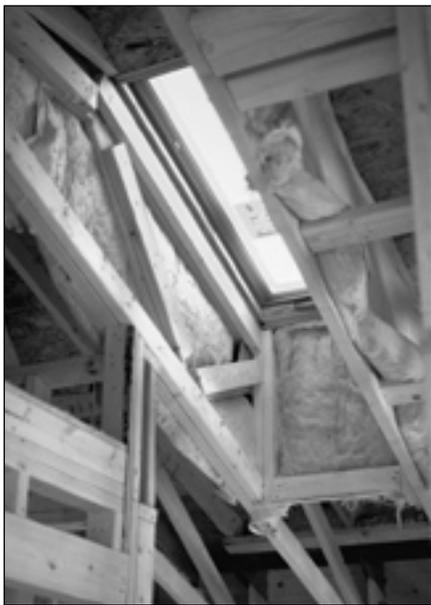
The code requires insulation to be in substantial contact with the wallboard and a vapor barrier to be installed on the warm side of the insulation. At this skylight well, insulation was held several inches back from the wallboard by framing. The vapor barrier was on the cold side of the insulation, a potential moisture trap.

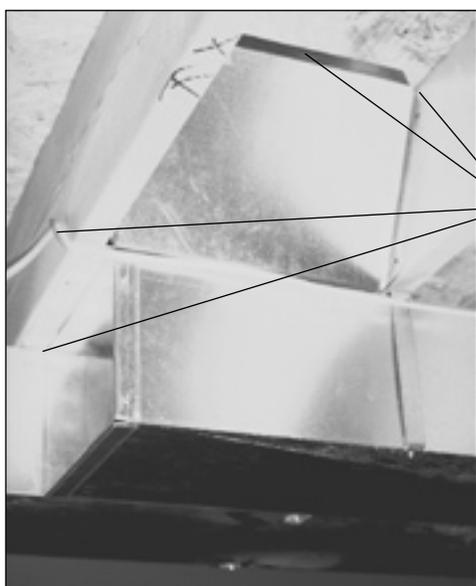
Typical leakage locations in return ductwork

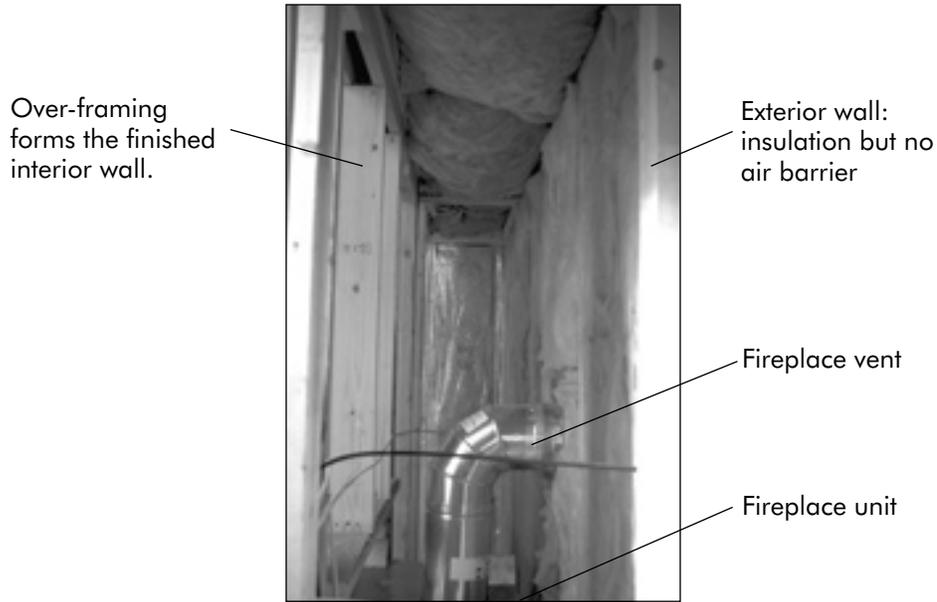
In this example, there was no air barrier at the exterior wall. This will allow outdoor air to move from the wall into the cavity around the fireplace unit and then, through cracks and holes, into the living space.

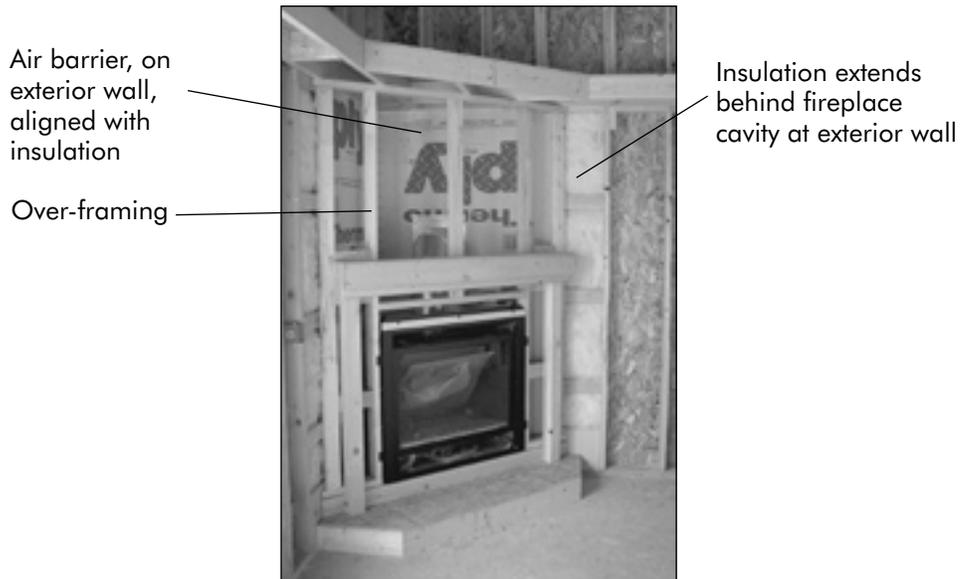
In this example, the insulation and air barrier, aligned at the exterior wall, were installed before over-framing was built and before the fireplace unit was installed. This approach will stop drafts and help the insulation perform effectively.

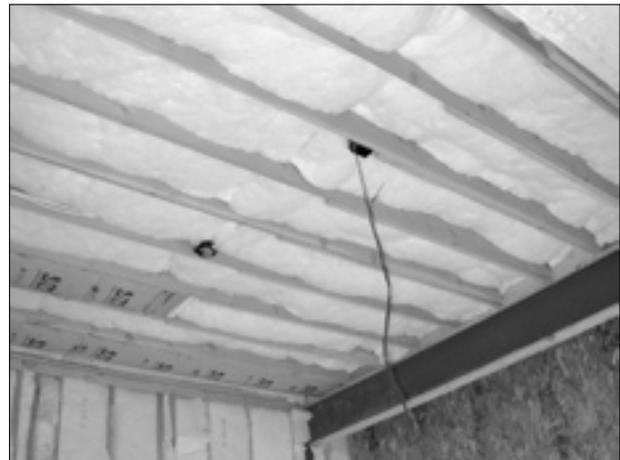
Code requires minimum R-19 insulation in floors above garages. The insulation must be in substantial contact with the subfloor above, permanently supported using one of several approved means. In this example, 6-inch thick R-19 fiberglass batts, installed in 9.25-inch joist cavities, were held in place only with staples—not an approved method. Some of the staples had failed prior to wallboard installation.

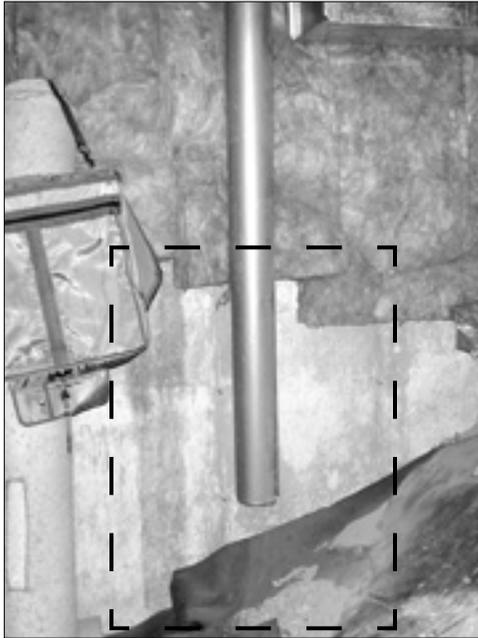
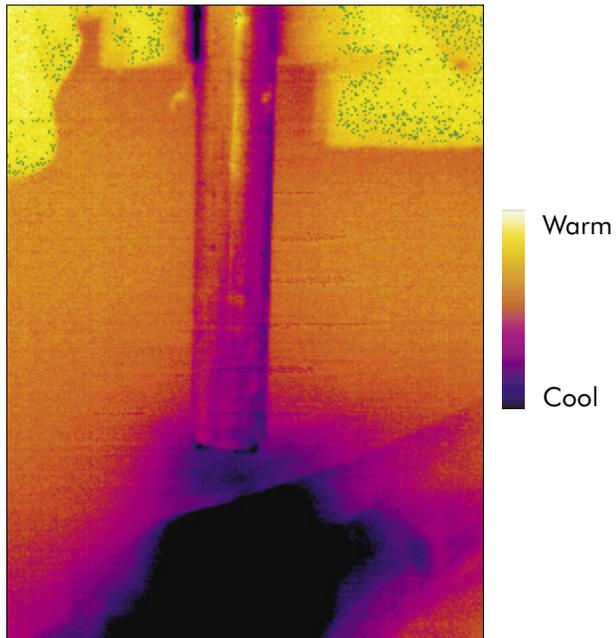
Code-required combustion air ducts, such as the one shown above, are direct openings to outside. An infrared photo of the same area (above right) demonstrates a typical winter problem: cold air is continually drawn in to replace air lost through other cracks and holes high in the house. This phenomenon contributed to cold basements and crawl spaces. In response, it was not unusual to see combustion air ducts plugged by homeowners—despite prominent labels warning against tampering with these safety devices.

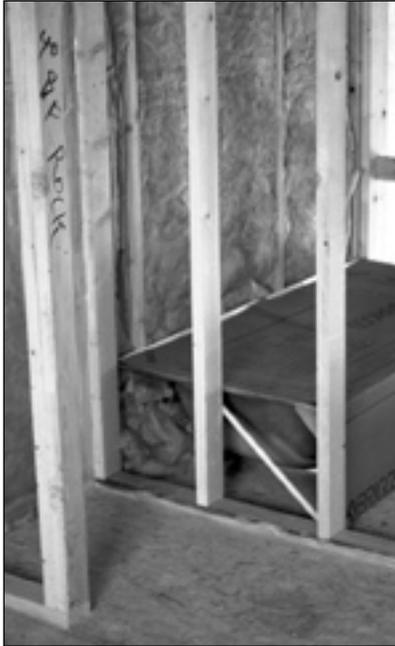
This bathtub had more than enough insulation at the exterior wall. But there was no air barrier to stop air from the outside wall from flowing through the insulation and circulating beneath the tub. From there, connections through partition walls and holes around the plumbing connected this leak to the rest of the house.

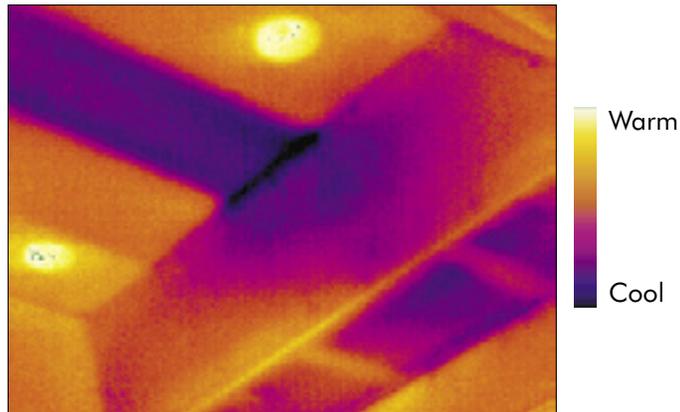
In this example of a vertical duct chase on an exterior wall, the insulation boundary and air barrier were properly aligned and installed with attention to detail. This eliminates thermal bypasses.

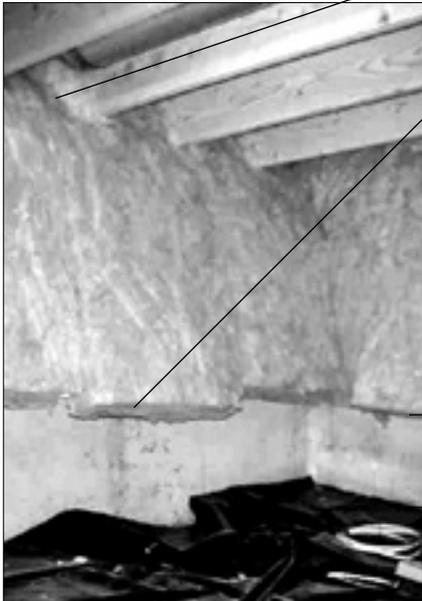
The batts hung away from the foundation by as much as 6 inches, allowing warm crawl space air to bypass the insulation.

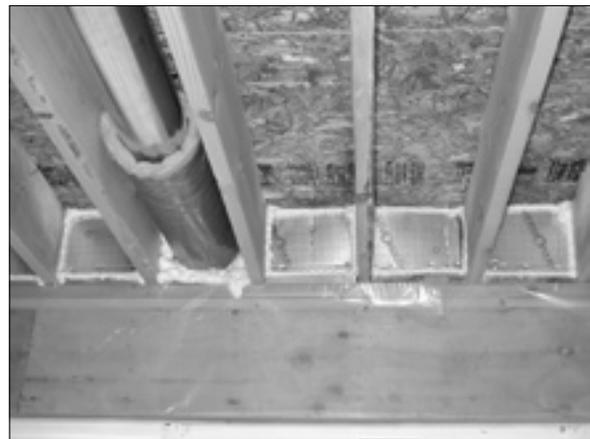
This photo illustrates an effective sealing job. Easily cut material, sealed at the edges, blocks air movement through the cantilever.

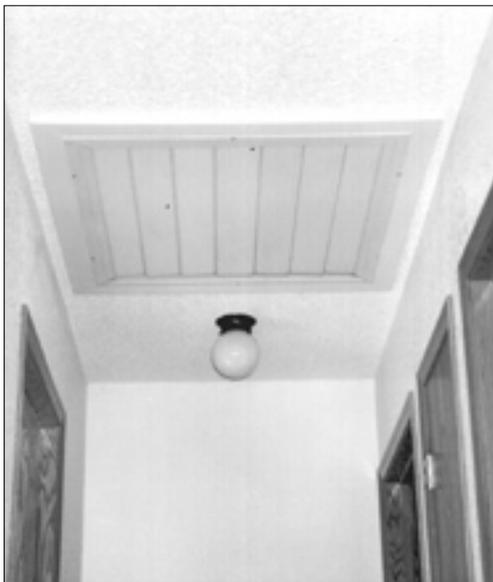
Whole house fan louvers were quite leaky even when closed. Code-required winter covers were provided to owners of two of the five post-group homes with whole house fans.

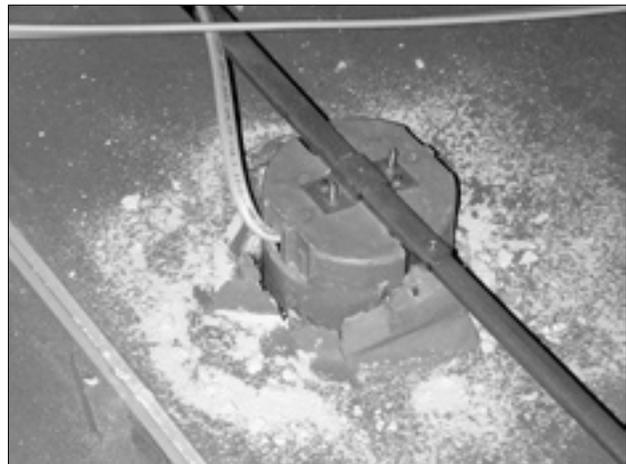
Air leaked around electrical boxes and through wiring penetrations.

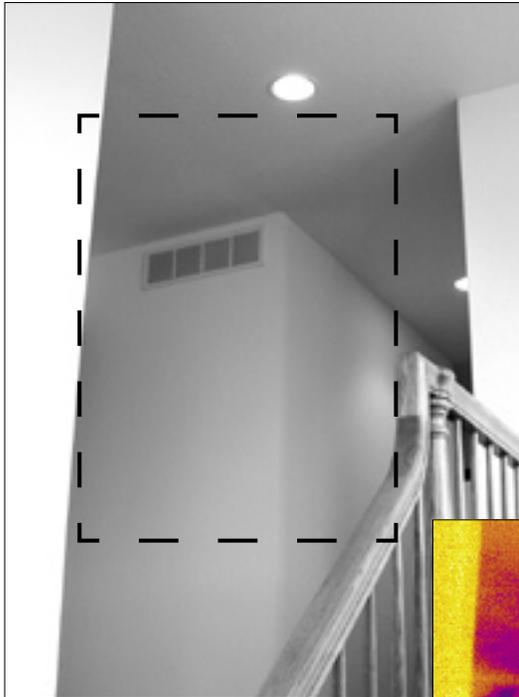
Air leaks through gaps between wallboard and framing. These gaps are skinny (1/16" to 1/8" typical) but extend many lineal feet.

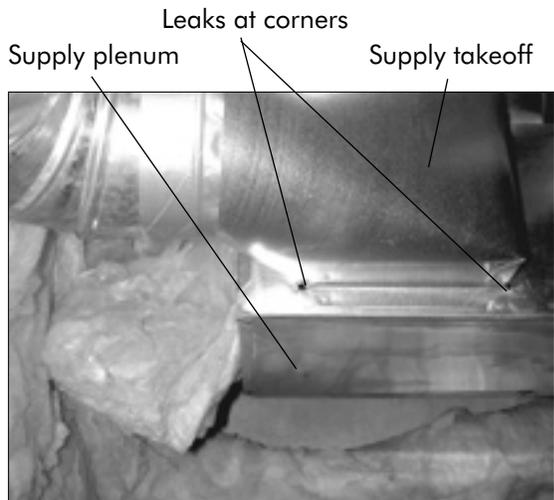
This joint between a takeoff fitting and a plenum is an example of small supply duct leaks. Some takeoffs were much leakier.

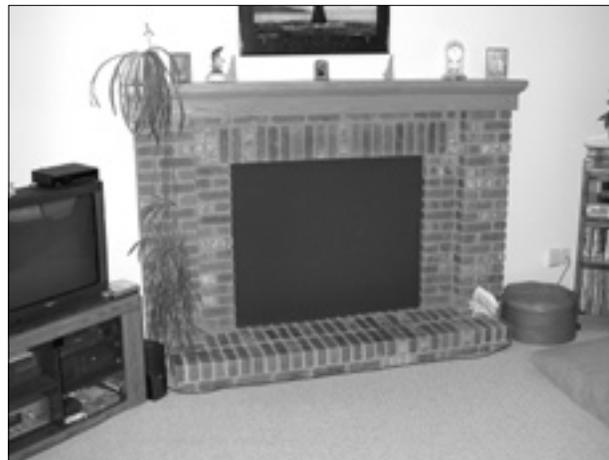
The owners of this house made a removable, fabric-coated foam insert to block drafts through the fireplace and make their living room more comfortable.

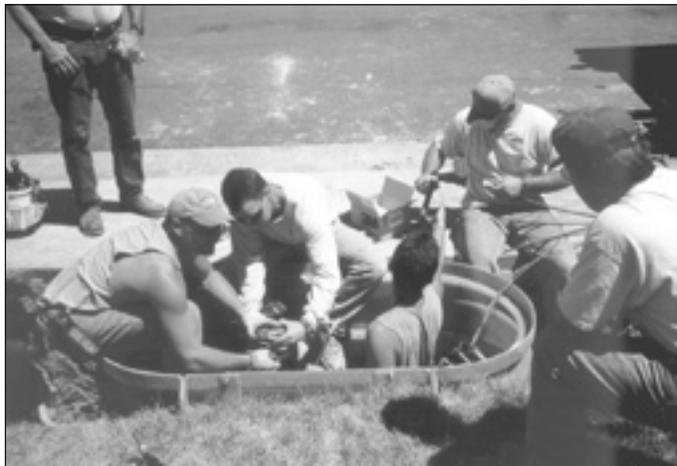
Fort Collins Utilities crew members change out a transformer that was overloaded under peak summer demand conditions.
