Evaluation of New Home Energy Efficiency

An assessment of the 1996 Fort Collins residential energy code and benchmark study of design, construction and performance for homes built between 1994 and 1999.

Summary Report

June 2002

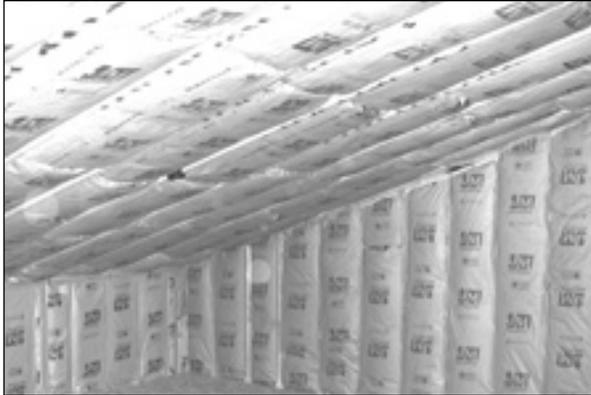
This is an example of effectively installed insulation that met code requirements. Batts filled the cavities, attained full loft, and will be in substantial contact with the wallboard.

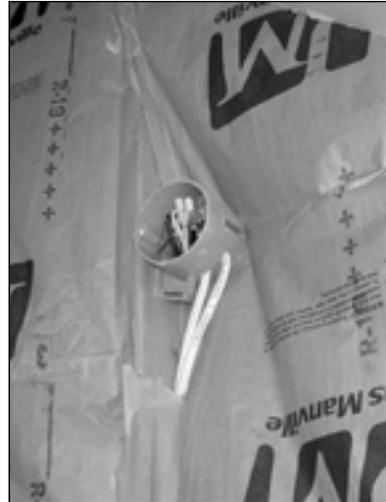
The code requires that insulation be cut to fit, without compression, around electrical and other obstructions in the insulated bay. In this case, insulation was compressed behind the box rather than cut to fit around it.

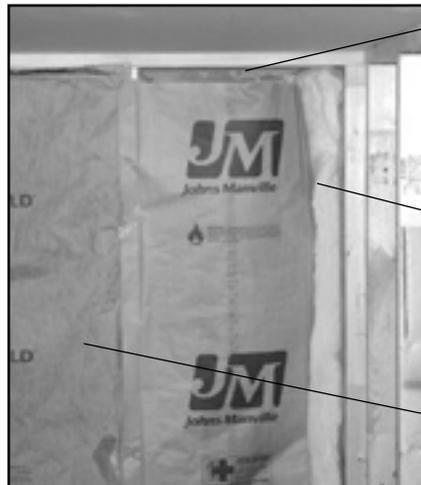
One-inch void at top of wall cavity

Batt folded rather than cut to width in non-standard-width cavity. This compressed the batt and caused air gaps

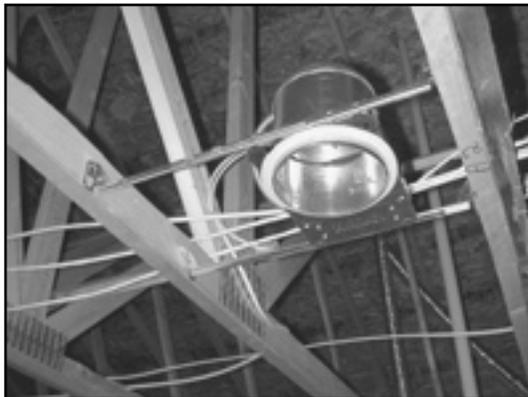
“Airtight” cans for recessed lighting reduced air leakage through insulated ceilings.

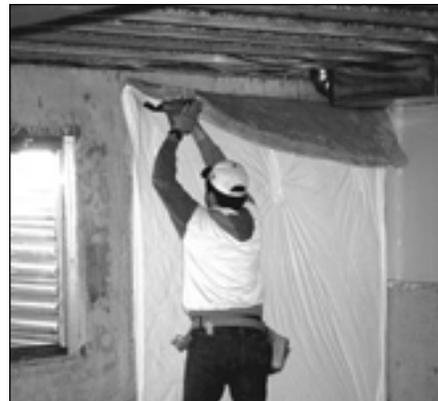
Basement wall insulation addressed one of the biggest remaining heat loss paths. The typical approach was a vinyl-faced fiberglass blanket on the interior of the concrete foundation.

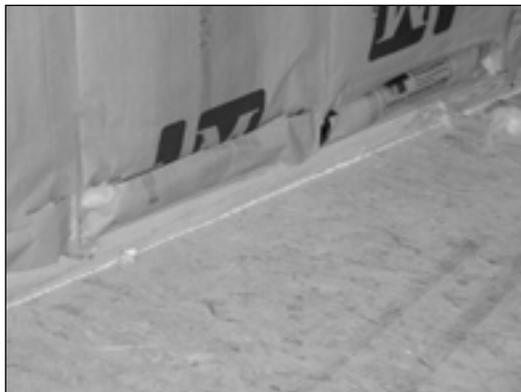
Sealing the baseplate-to-subfloor joint cut off a significant air leakage path.

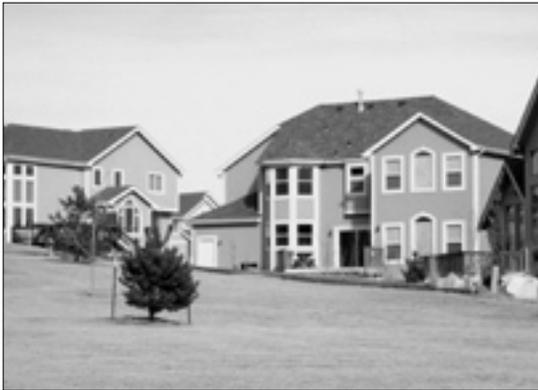
Large expanses of glass faced in all directions.

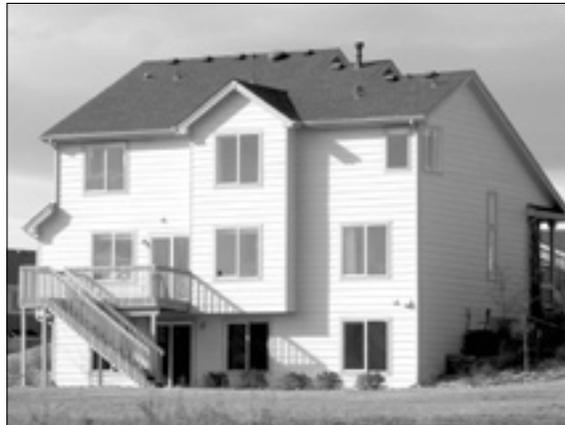
Some study homes had a lot of south-facing glass area, offering the potential for great passive solar performance. However none were designed to take advantage of the solar heat during the winter (by storing the heat) or to avoid the sun during the summer (with exterior shading). During the winter, these homes tended to have large temperature variations from one part of the house to another.

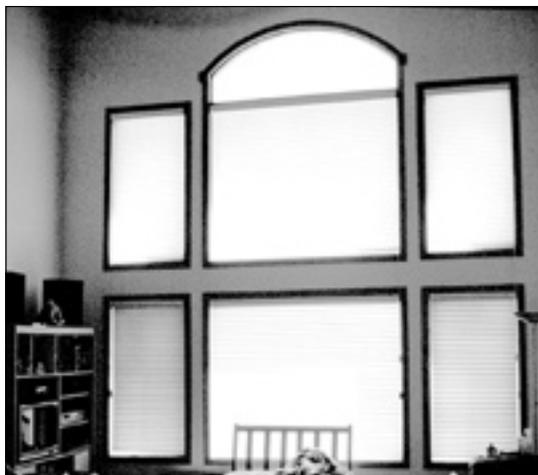
The testing contractor noted that some homeowners kept window coverings closed to ward off too much heat and glare.

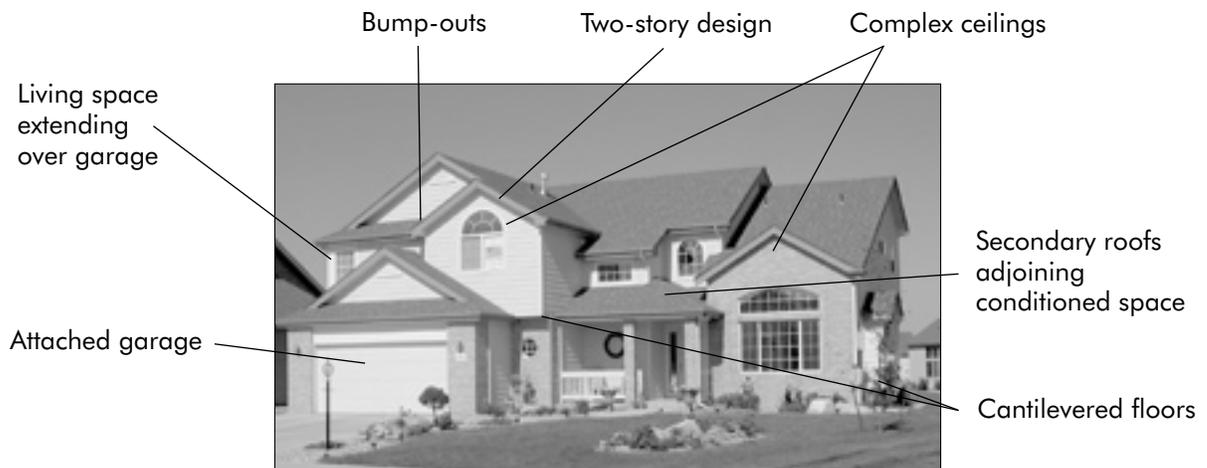
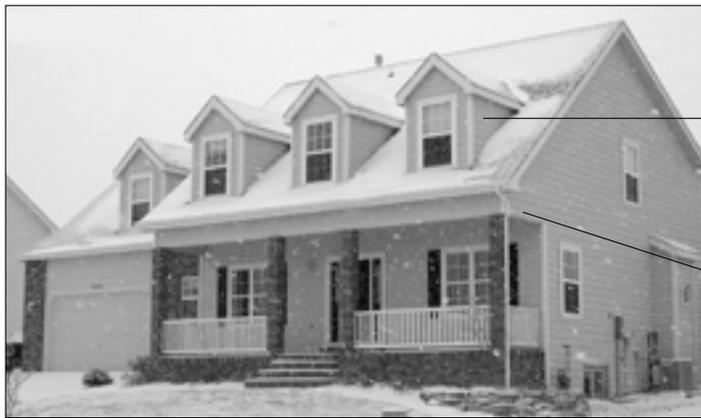
This house provides examples of many common architectural features that were associated with problems in the study homes.

Dormer

Upper level floor
cantilevered over
front porch

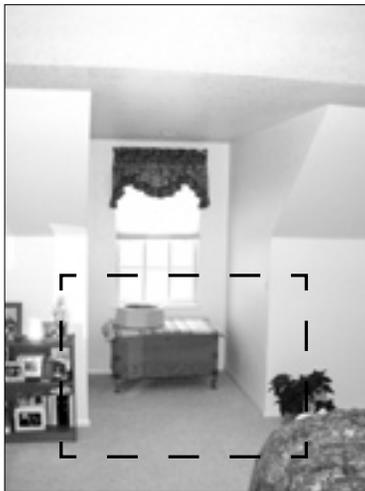
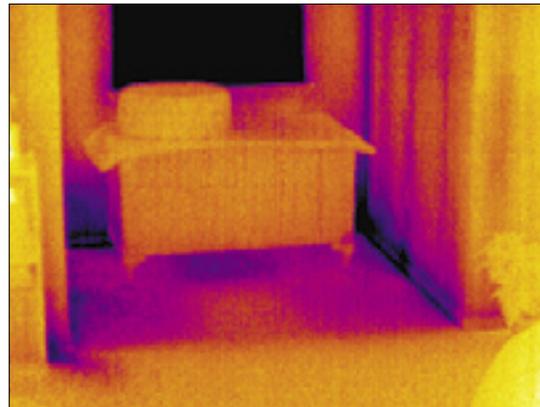
The upper level dormers and cantilever floor in the house shown above posed air sealing and insulation challenges. From the interior (conventional photo lower left, infrared photo lower right), thermal flaws showed up as cold spots (dark). These can cause discomfort and provide opportunities for moisture condensation, mildew and mold growth. The owners of this house complained that the dormers were so cold that they could not use these areas during the winter.

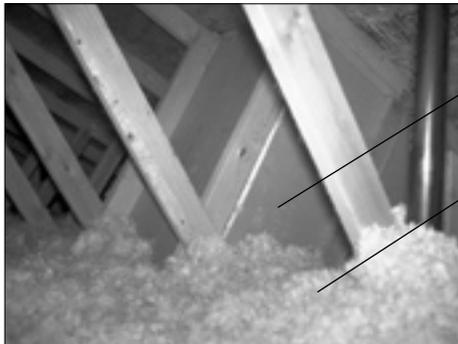
Uninsulated components, such as this skylight well, were occasionally observed.

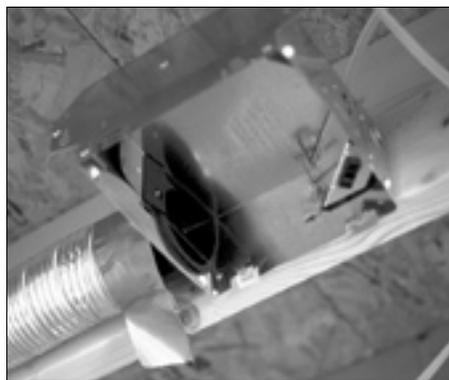
The duct venting this bath fan outdoors was only tenuously attached by tape to the fan housing. After wallboard was installed, there was no way to check or fix this connection.

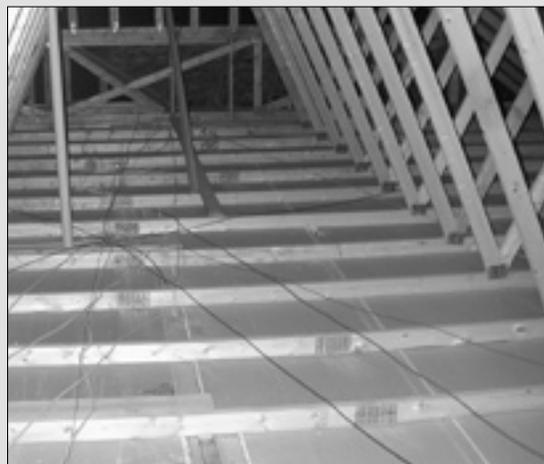
The problem, quickly discovered in a January 2000 site visit by City staff: no attic insulation. Yet the code-required *Insulation Disclosure* form, on file at B&Z, signed by the insulation contractor, documented 12 inches of an unidentified insulation material, rated R-38, in the attic. Once the builder was notified of the problem, insulation was installed within 48 hours. The comfort of the home improved dramatically with this change.

The missing insulation was clearly an oversight, never caught by quality control. Apparently neither the insulation contractor, the builder, nor the City's inspectors ever looked in the attic. There was also clearly a major failure in the builder's callback response; the problem was not identified in at least three return trips to the house. As a result, the owners paid an estimated \$150 more than necessary to heat and cool the home. The occupants put up with miserable comfort for six months and were generally jaded about new homes. The builder's site

Several months after occupancy: no insulation in the attic.

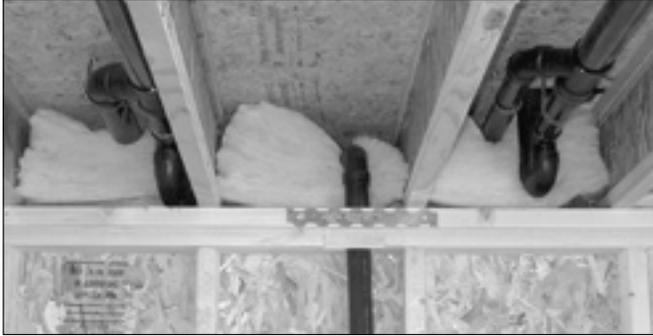
Compression of the insulation batts, voids, and the lack of contact with the subfloor above this cantilever all reduce the effective R-value of this insulation.

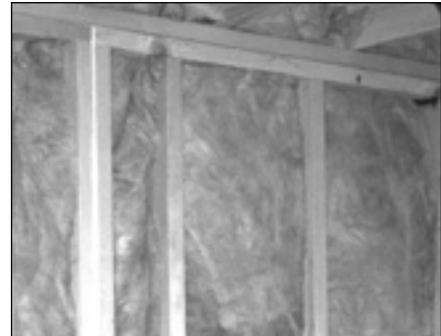
Typically-installed, unfaced fiberglass batts in a frame wall will offer reasonable performance. Note some compression of the batts in the full-width stud bays and more severe problems where a batt had to be cut to fit in a narrow cavity.

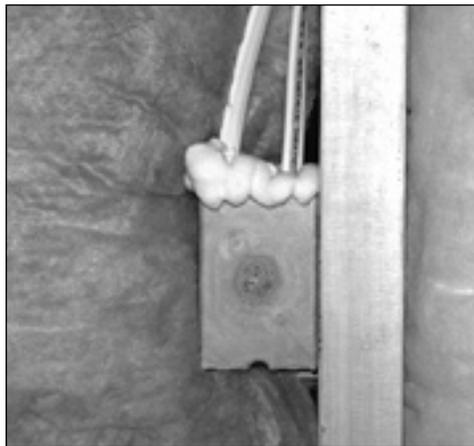
Fiberglass batts were often improperly fit around obstructions like this electrical box, creating cold spots. (This is the back of the box; code requires a minimum of R-5 insulation behind such obstructions.)

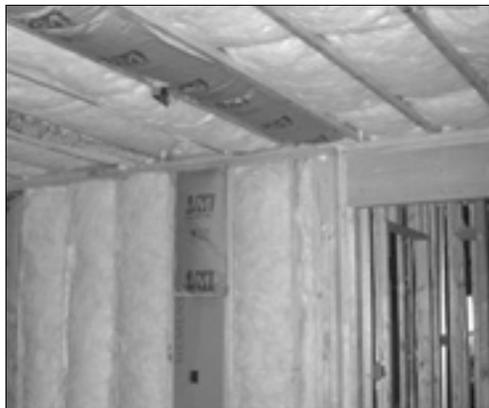
In floors over garages, R-30 batts exceeded code R-value requirements but were easier to install effectively because they were thick enough to fill the floor joist cavity completely.

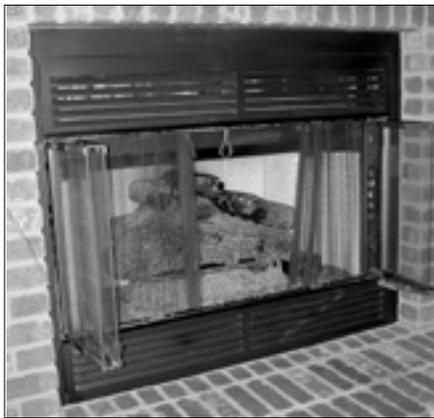
The flue, draft hood and outdoor air supply all contributed to leakage through atmospherically vented fireplaces.

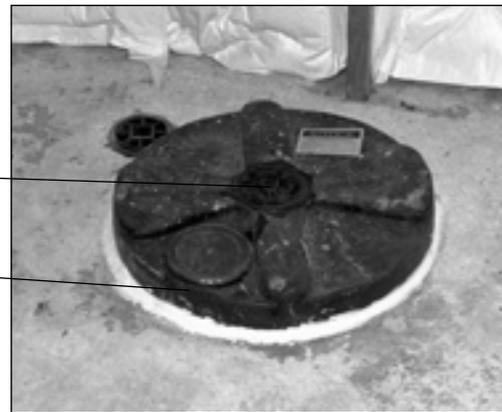
Open hole
No sealing at perimeter of cover

When air is drawn through an unsealed sump cover, it might bring with it radon, other soil gases or moisture.

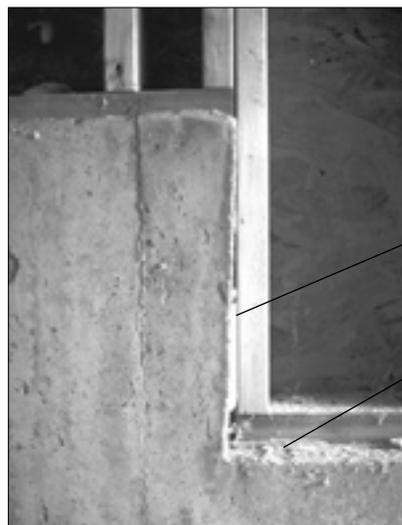
Horizontal joints between the foundation and mudsill were usually effectively sealed, but the vertical sections on a stepped foundation rarely were. In an unfinished basement, such a joint leaks directly to the outdoors.

No sealant

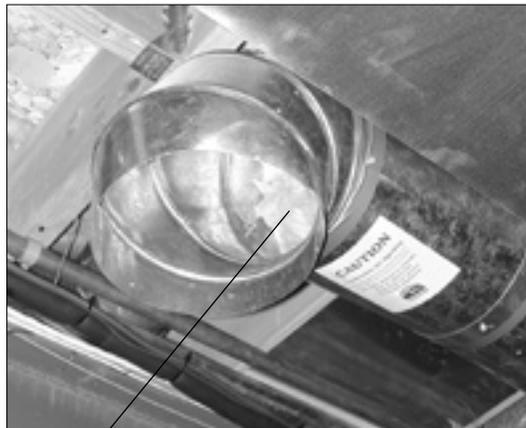
Code-required combustion air ducts, such as the one shown above, are direct openings to outside. An infrared photo of the same area (above right) demonstrates a typical winter problem: cold air is continually drawn in to replace air lost through other cracks and holes high in the house. This phenomenon contributed to cold basements and crawl spaces. In response, it was not unusual to see combustion air ducts plugged by homeowners—despite prominent labels warning against tampering with these safety devices.

Plug inserted by homeowner to stop cold draft

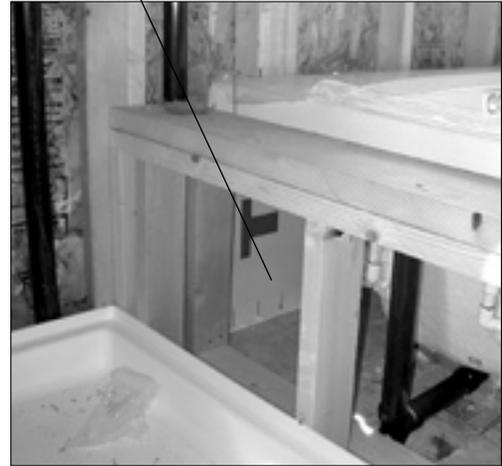
An air barrier behind the tub will block air flow.

The solution is easy and inexpensive, but requires a change in construction sequence. The air barrier behind this tub was installed before the tub was set in place. This was observed in about half of the homes under construction.

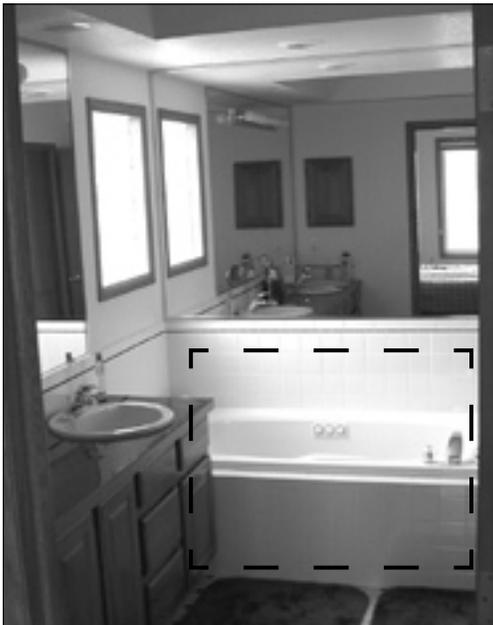
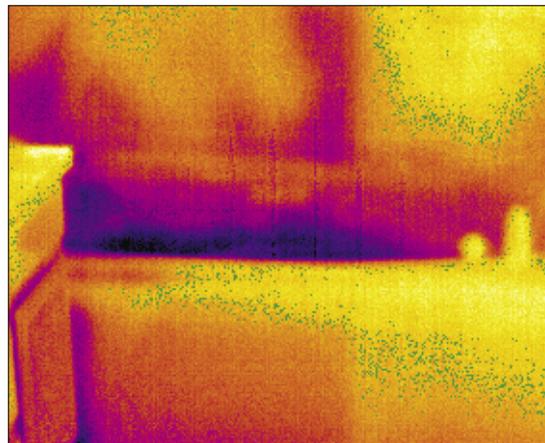
The infrared photo above shows the symptom of a missing air barrier: a cold tub. This bathtub sat against two exterior walls and over a garage. Cold outdoor air moved through or around the insulation to cool the tub. (Infrared photo taken with blower door operating.)

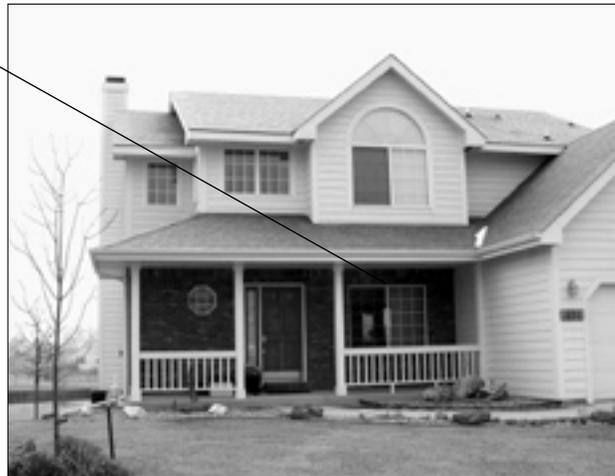
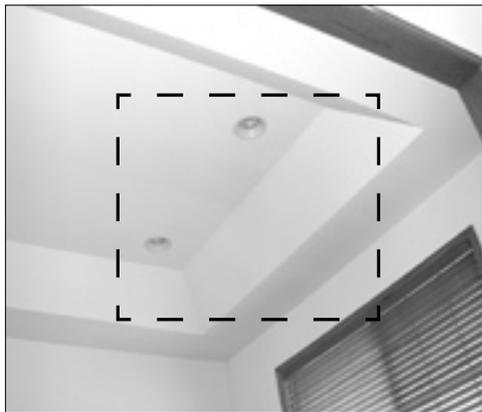
In the house shown at right, a portion of the air barrier that should isolate interior space from the porch roof was missing. As seen from the interior (conventional photo lower left, infrared photo lower right), cold air could enter the house through the joist cavity between main and upper levels. Cooling effects of this leak extended into interior partition walls at the core of the house. (Infrared photo taken with blower door operating.)

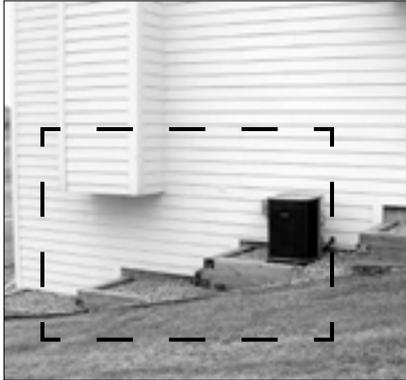
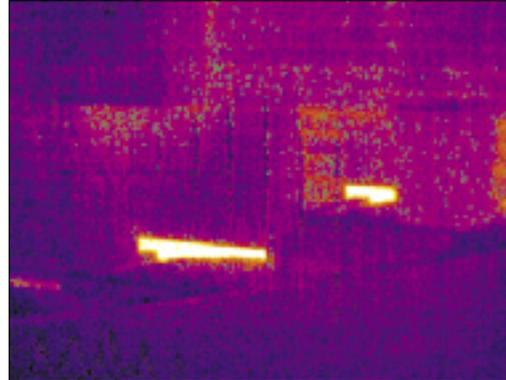
Uninsulated. Strips of concrete exposed above grade in this stepped foundation stood out as hot spots compared with the insulated frame wall and earth. Eight inches of concrete provide only about R-1 resistance to heat flow.

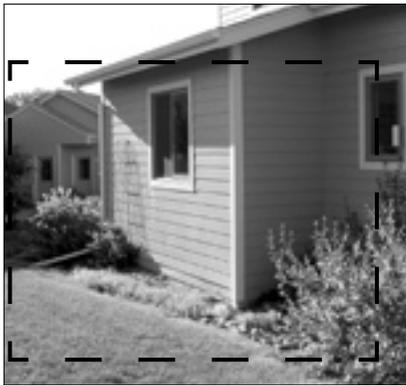
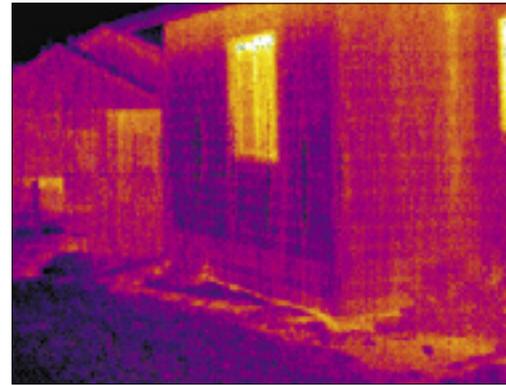
Insulated. In this house, the exposed portion of the foundation was not significantly warmer than the adjoining wall and earth.

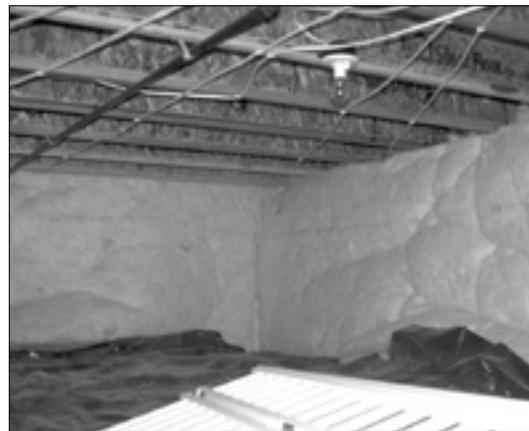
The batts hung away from the foundation by as much as 6 inches, allowing warm crawl space air to bypass the insulation.

Batts hung 18 to 24 inches short of the interior grade.

Although the code-required R-19 perimeter insulation was present in this crawl space, the rated R-value was compromised by installation flaws.

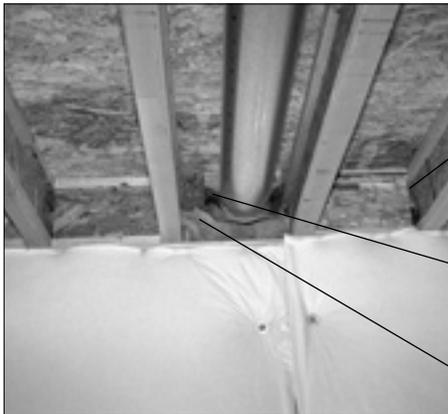
Rectangular blocking coupled with engineered "I-beam" joists left large gaps at the edges.

Blocking was removed where the heating duct penetrated the cantilever.

Insulation only filled part of the cavity.

Interior view of some cantilever problems. It is not clear whether the air barrier was intended to be at the interior blocking or at the exterior soffit.

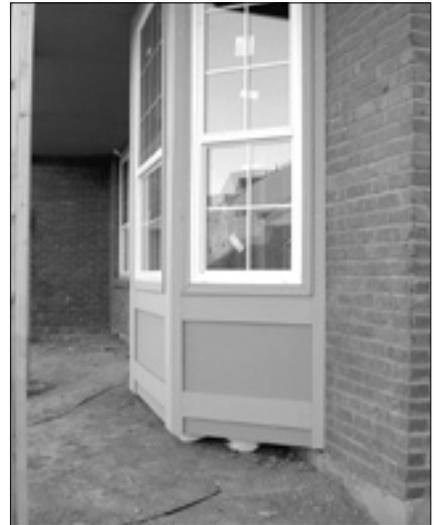
Main level cantilevers posed access challenges because they were so close to grade. There was no soffit on this one. The construction superintendent was aware of the problem and planned to dig a hole to be able to install it.

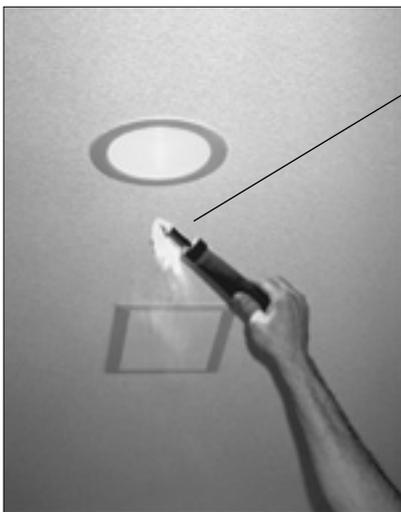
Smoke source made air movement visible.

Blower door tests often revealed large amounts of air leaking through recessed lighting located in floors with heated space above and below. This could be a symptom of leaks in the air barrier at an exterior cantilever; air moved through the floor joist cavities to exit at the light cans.

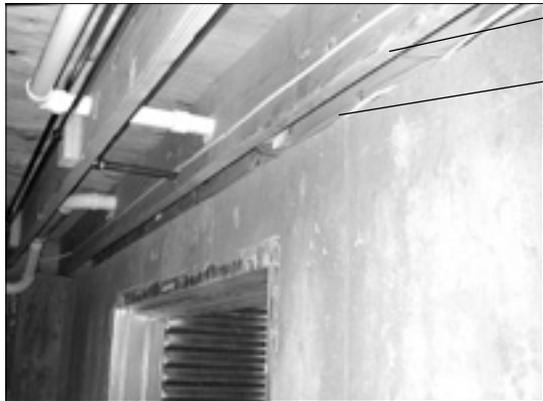
When the first floor joist was framed tight to the foundation, it left little space to insulate the rim joist. Plumbing and wiring complicated the job in this example.

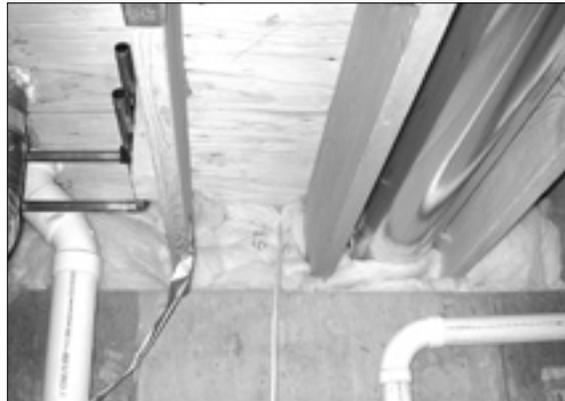
Many obstructions—such as the plumbing and ductwork shown here—made it harder to insulate rim joists effectively. Even where nothing was in the way, insulation was sometimes placed in cavities with insufficient attention to detail. Also note there was no vapor barrier to prevent moisture from reaching the rim joist.

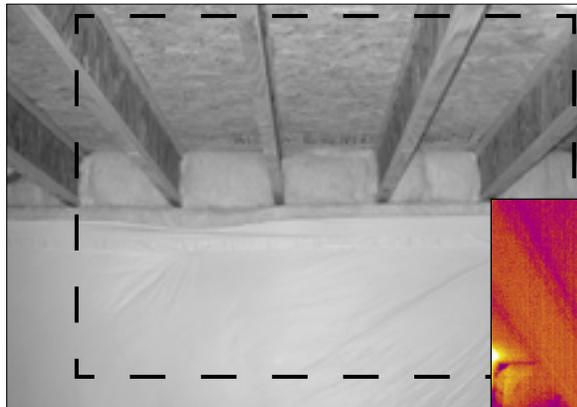
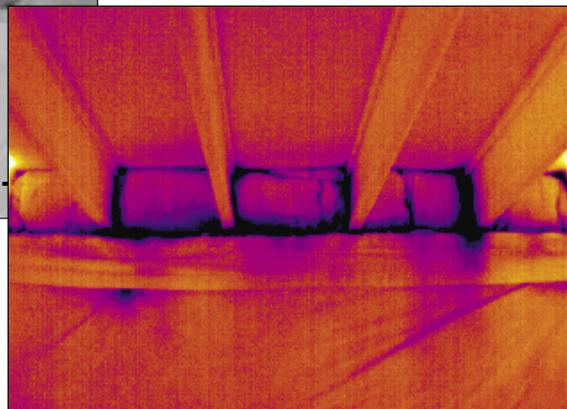
The infrared photo (right) shows the symptoms of compressed insulation and air leakage at the rim joist.

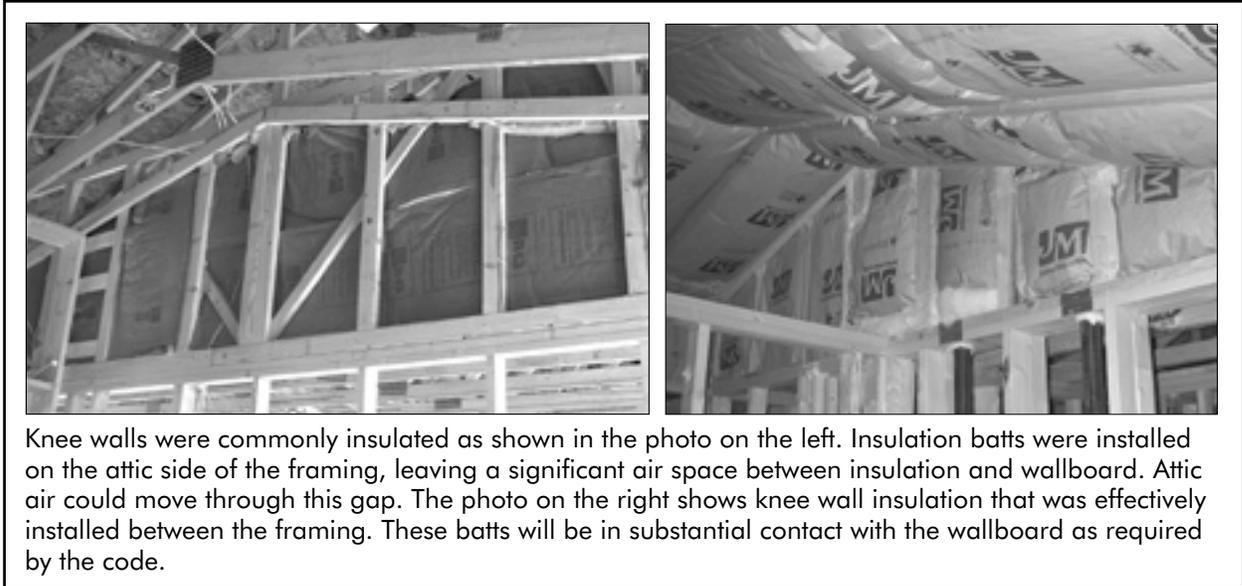
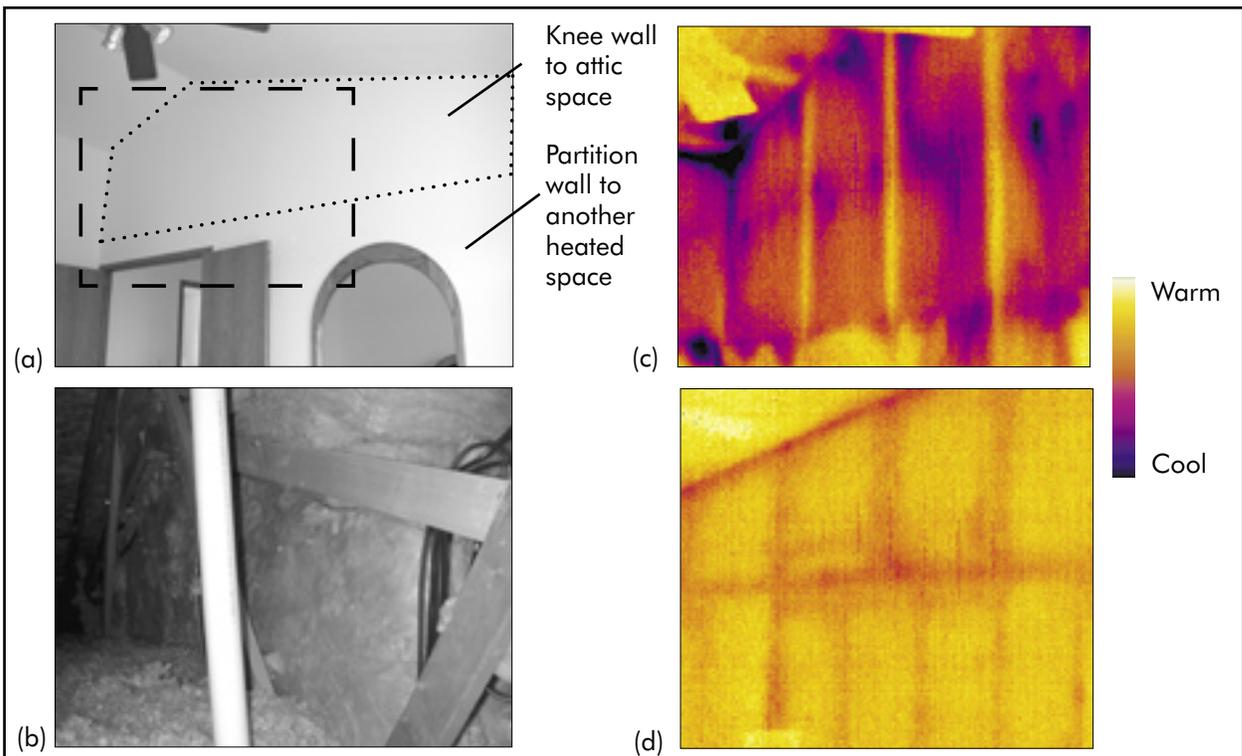
This group of photos illustrates kneewall practices and performance. Photos (a) and (b) show two views of the same kneewall. From the attic (b), the knee wall insulation appeared to be installed well. But there was a large air gap between the insulation batt and wallboard. There was also no sheathing on the attic side. There was nothing to prevent attic air from circulating and pulling heat from the gap between the insulation and wallboard. Infrared photo (c) shows an irregular temperature pattern reflecting the inconsistent thermal performance of the knee wall insulation. Note the framing was warmer than the cavities. For comparison, photo (d) shows an exterior wall in the same room. It displayed the more uniform temperature pattern of a well-insulated wall; framing was cooler than the insulated cavities.

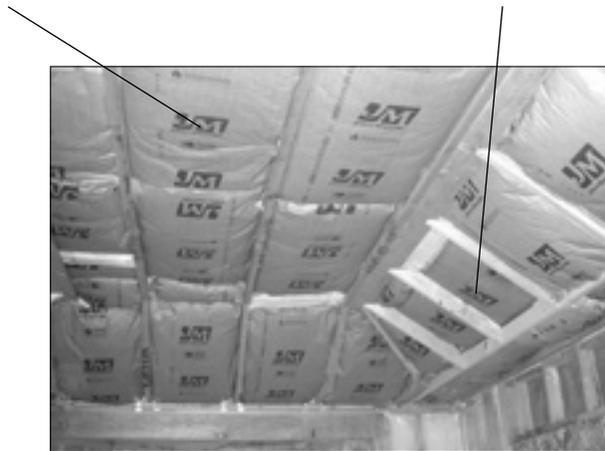
In some areas, the insulation was held back much further. This will leave gaps in which attic air can circulate between insulation and wallboard.

Vaulted and cathedral ceilings tended to have more insulation installation problems than flat ceilings.

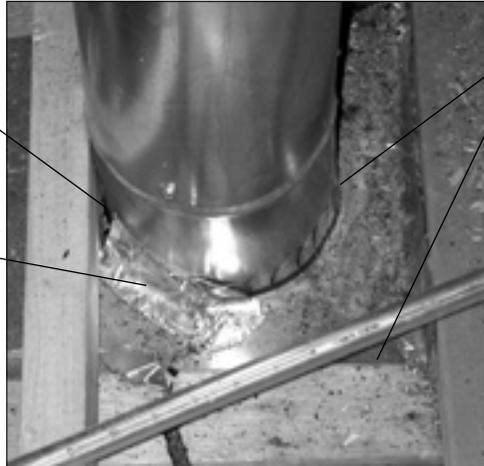
Though many penetrations were sealed, there were often many remaining opportunities for air to move between conditioned spaces and attics.

Significant gap where access to seal was difficult

Tape is a temporary seal that will probably fail in a few years.

These joints should have been fully sealed with long-lasting caulk.

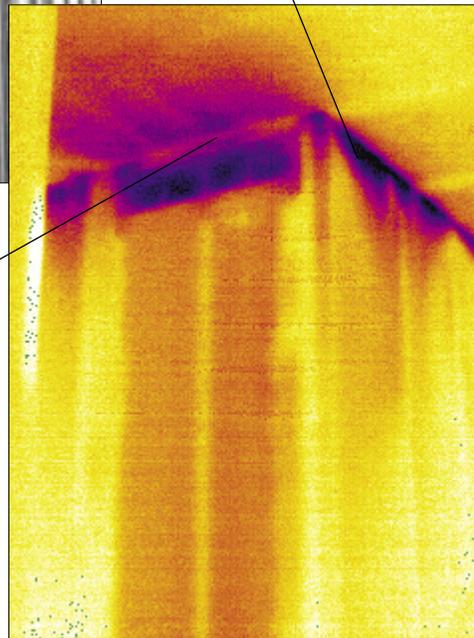
Air leaks through gaps between wallboard and framing. These gaps are skinny (1/16" to 1/8" typical) but extend many lineal feet.

Blocking above return grille and wall cavity return was very leaky

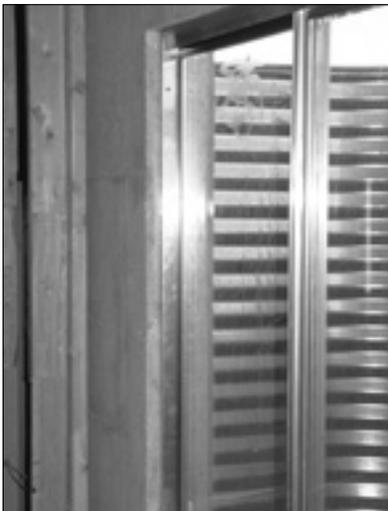
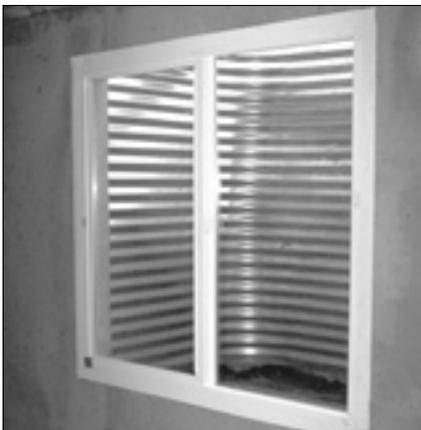
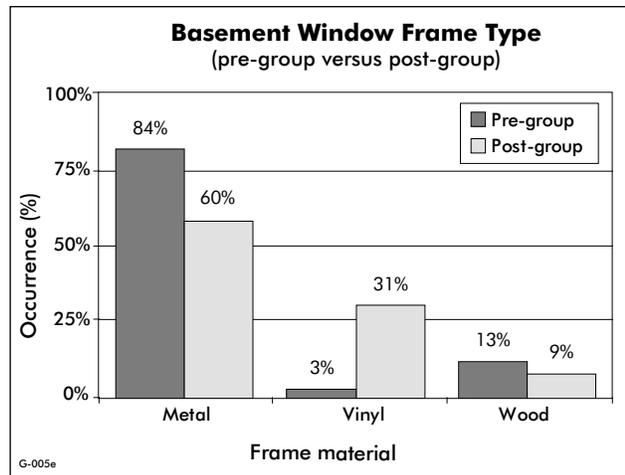
The majority of study home basement windows used metal frames. However, there was a significant increase in the use of vinyl-framed windows in post-group homes.

An aluminum frame with no thermal break, set into a steel buck poured in place with the concrete foundation (above left), offered the lowest up-front cost, yet delivered the poorest thermal performance. The use of a vinyl frame, also set into a steel buck (left), offered one step better performance.

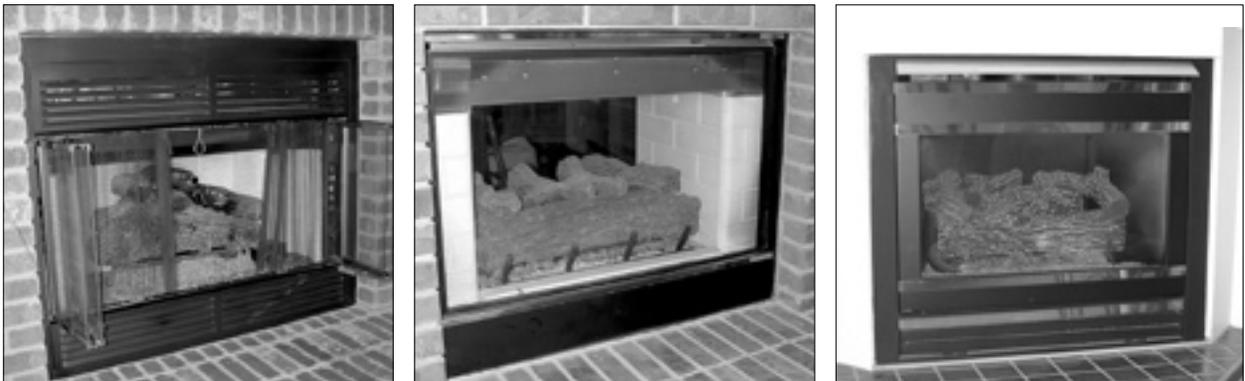
Three types of natural gas fireplaces were observed in study homes: atmospheric gas log sets with operable glass doors (left), atmospheric fireplaces with solid glass facades (center), and direct-vent units (right). The atmospheric units rely largely on house air for combustion and dilution air, whereas the direct-vent units draw all required air directly from outdoors.

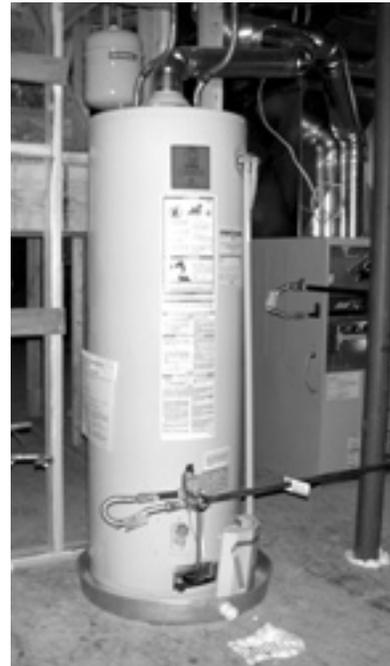
Atmospheric gas water heater

Gas-fired, atmospheric water heaters were the norm, raising concerns about combustion safety.

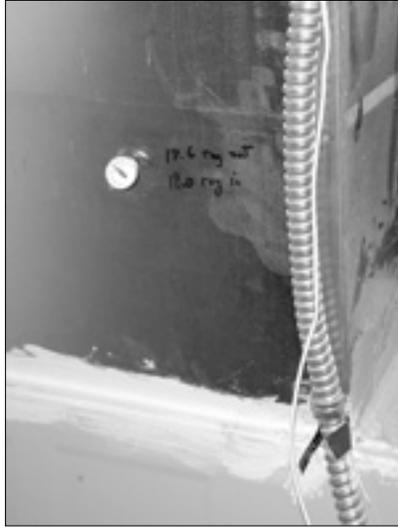
The only way to know whether a furnace is operating within the manufacturer-specified heat rise range is to measure heat rise. This test requires minimal tools and time. The testing contractor saw no evidence that heat rise had been measured on study home furnaces.

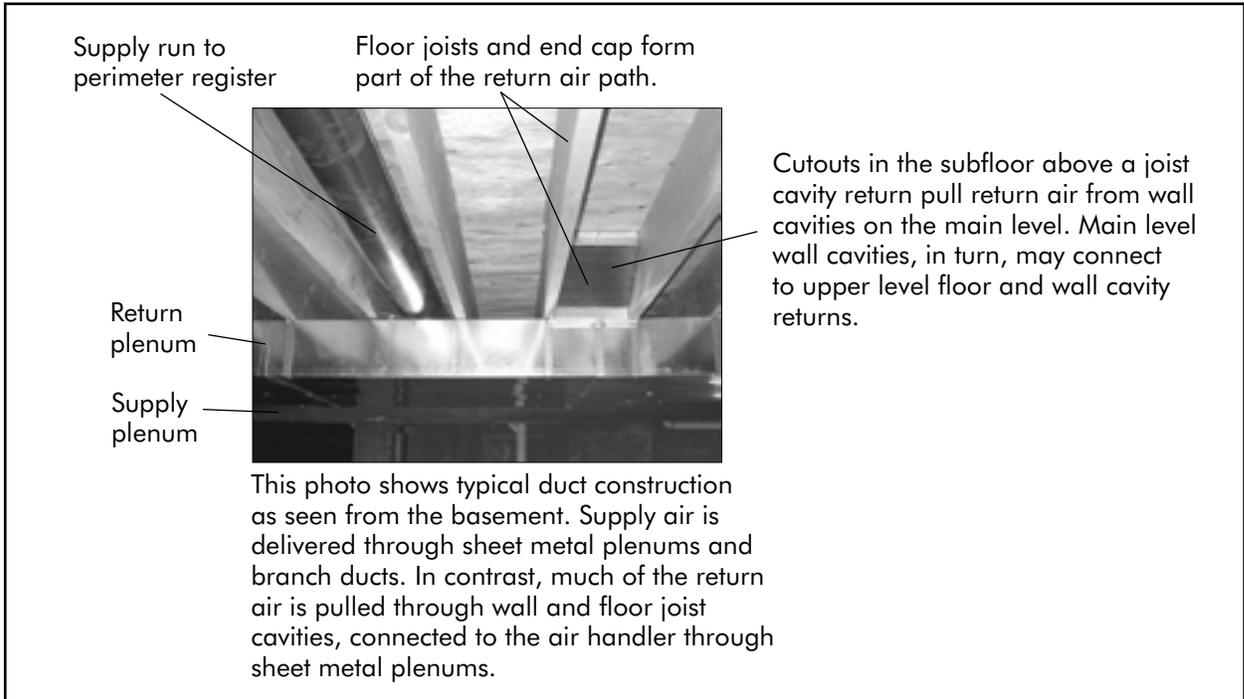
The photo below shows a basement view of duct system components in a typical study home. Residential duct systems were rarely fully specified on a set of plans; instead, the installer laid out and constructed the ductwork on site after the homes were framed. This often presented challenges to installers who had to establish paths for air flow between the air handler and every room in the house. Supply ducts were constructed of sheet metal components. Floor joist cavities and wall stud cavities often comprised a large portion of the return air ducts, coupling with sheet metal plenums near the air handler.

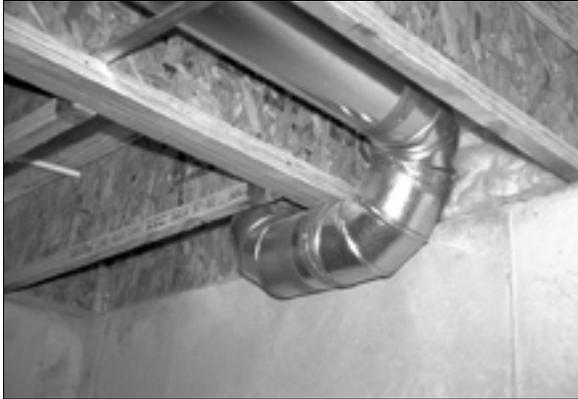
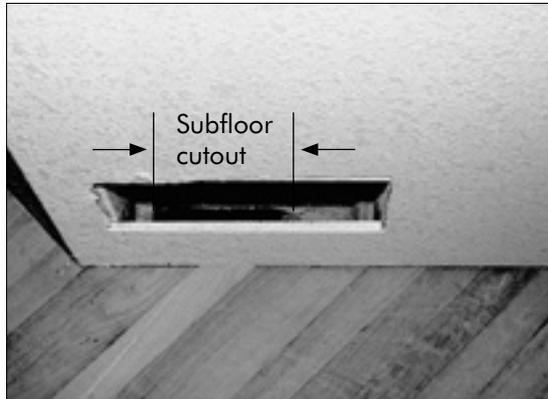
The photos illustrate construction practices that compromised duct system air flow performance. Significant flow constrictions were observed in some homes. As the duct leakage data indicates, duct leakage was an issue in every study home.

Air flow was sometimes reduced by constrictions or “choke points” at certain places in the ductwork. In the left photo, three elbows were needed to get a supply run past a structural member that could not be breached. Each elbow was equivalent to several feet of straight ductwork. The connection was made, but air flow was compromised due to large pressure drop. In the right photo, the cutout in the subfloor—that provides a path for return air back to the air handler—was much smaller than the register cutout on the wall.

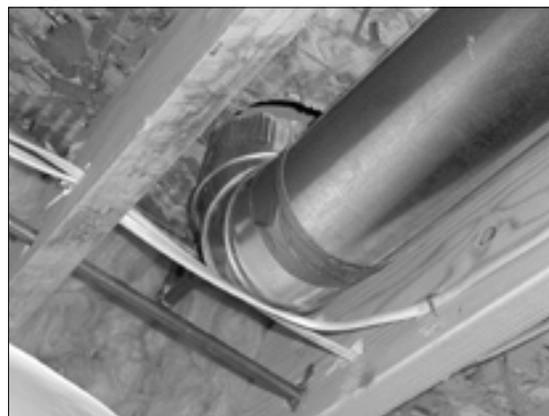
This supply duct was never connected to anything on the top end. Carpet was laid over the subfloor cutout, and the register was never installed.

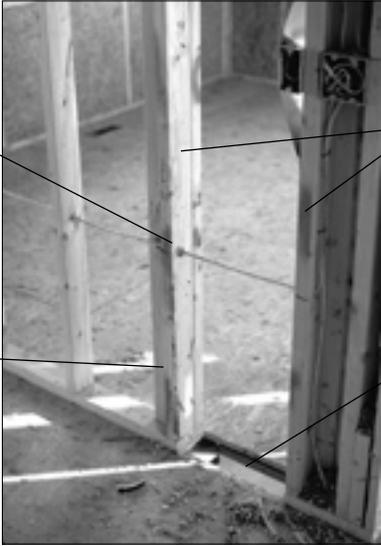
Wiring penetrations will be small leaks.

The cavity will leak everywhere there is a joint between wallboard and framing.

These wall studs formed two sides of a return duct. Wallboard will complete the other two sides.

Return air will be drawn through this cutout on its way back to the air handler.

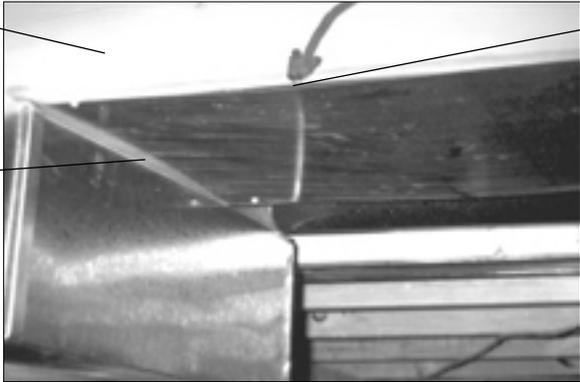
Return air was pulled through this joist cavity.

Leaky joints between sheet metal plenums and floor cavity returns

Panning did not seal to the framing.

Return leaks involved both sheet metal and building cavity portions of the ductwork.

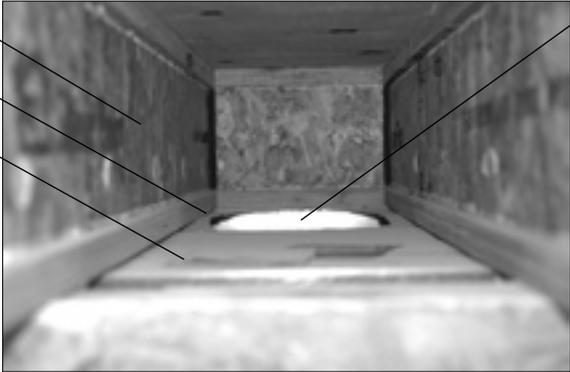
Large, unused cutout

Sometimes individual leaks were large. This sheet metal return plenum was cut open to pull air from the floor joist cavity. The return run was then moved to an adjoining cavity, but this 12" x 15" cutout was never sealed.

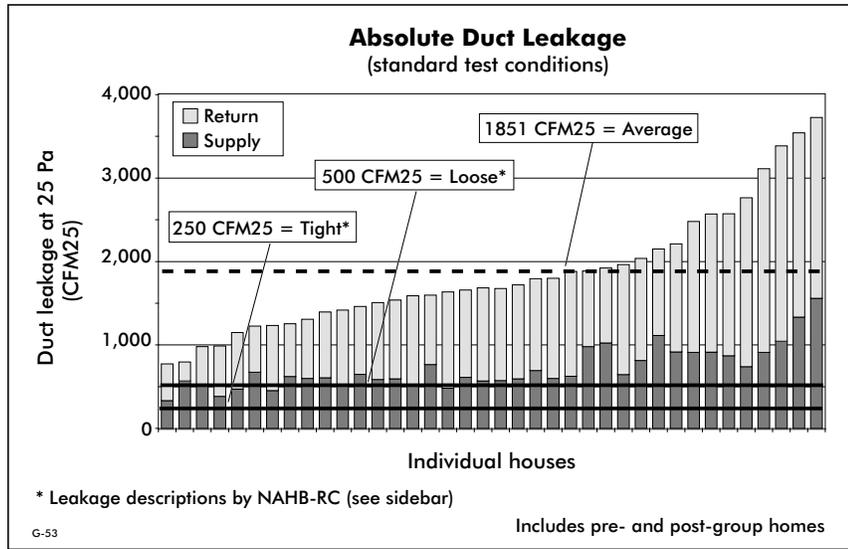
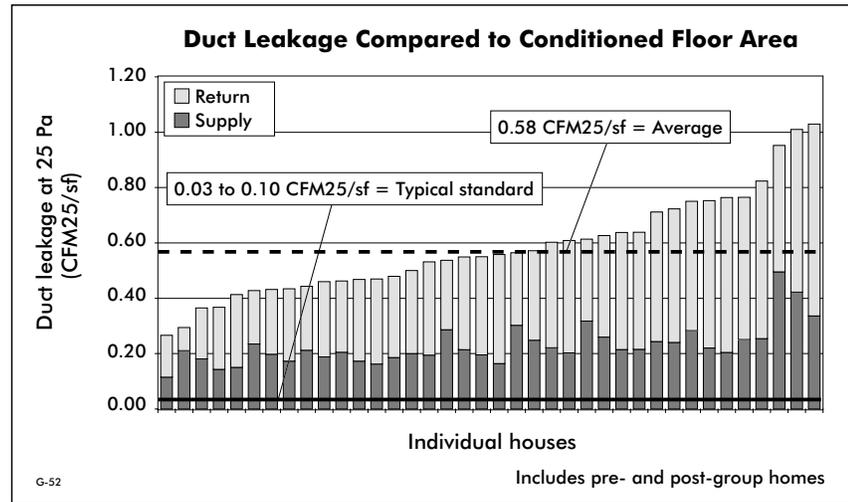
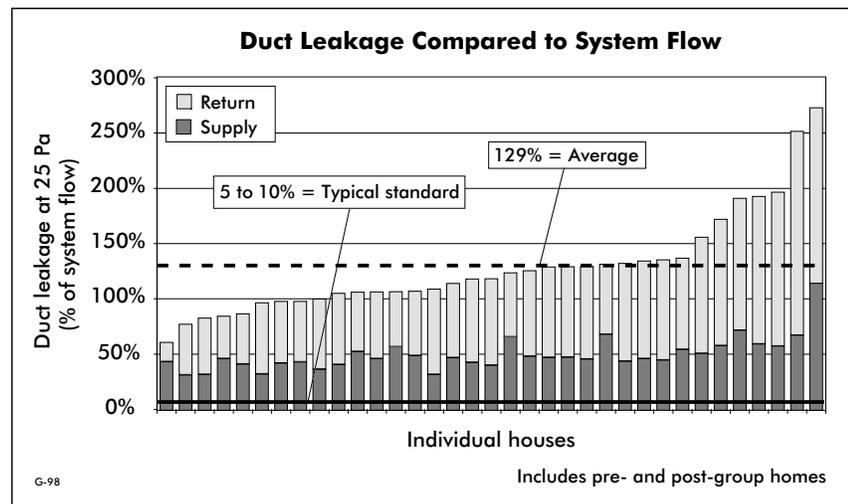
Measured duct leakage was very large in every tested home. The graphs present leakage results using three different units and compare leakage against representative standards (see sidebar on previous page). Depending on the specific unit and standard chosen, the average study home ductwork was six to 25 times leakier than the standards.

These graphs show measured duct leakage in absolute units (top), leakage compared to the size of the house (middle) and leakage compared with system air flow (bottom). Standards used elsewhere are shown for reference.

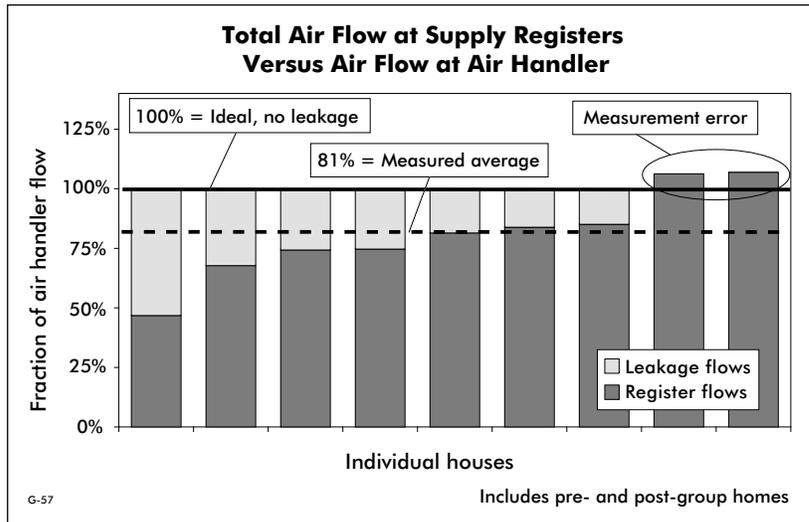
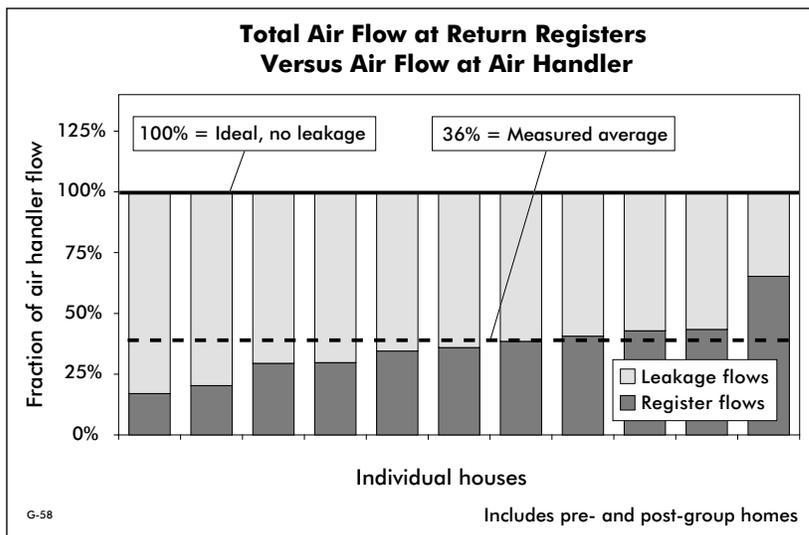
Comparison of air flows at registers versus the flow through the air handler provided further evidence of the magnitude of duct leakage.

In a subset of homes, air flows were measured at each register. The total of the individual register flows was compared with the measured flow through the air handler. On average, about 80% of the flow through the air handler reached supply registers, while only about one-third of the air handler flow was drawn from return registers (the balances were made up via leakage).
