Evaluation of New Home Energy Efficiency

An assessment of the 1996 Fort Collins residential energy code and benchmark study of design, construction and performance for homes built between 1994 and 1999.

Summary Report

June 2002

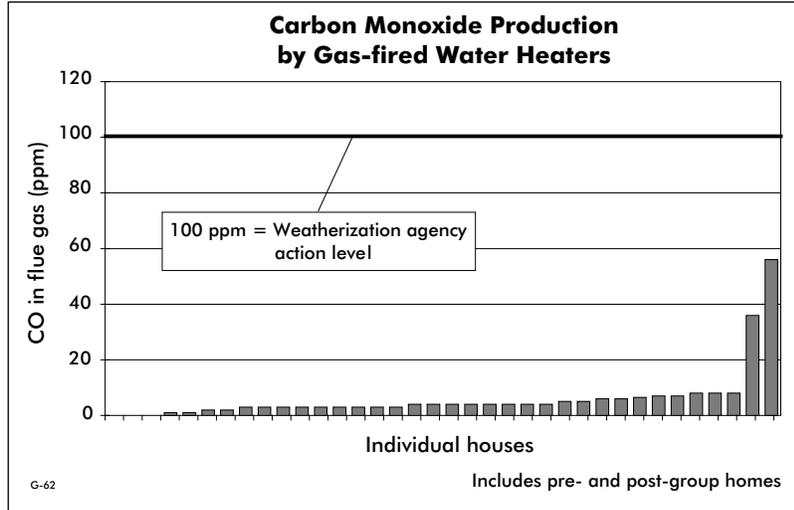
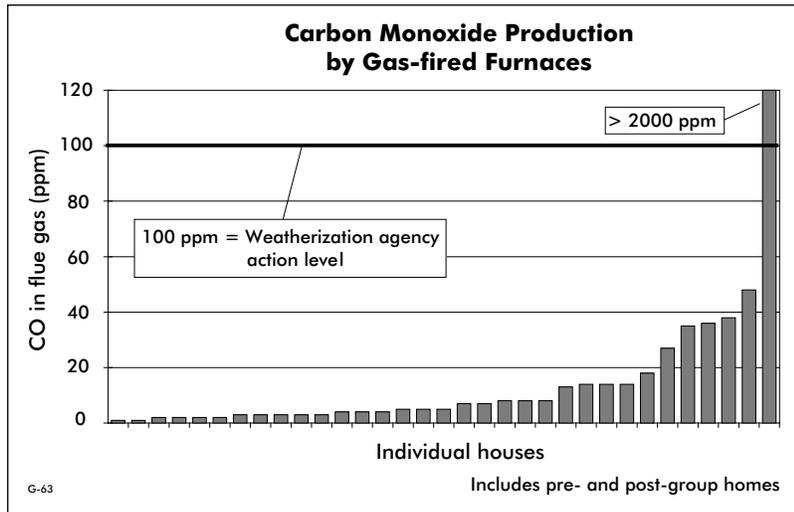
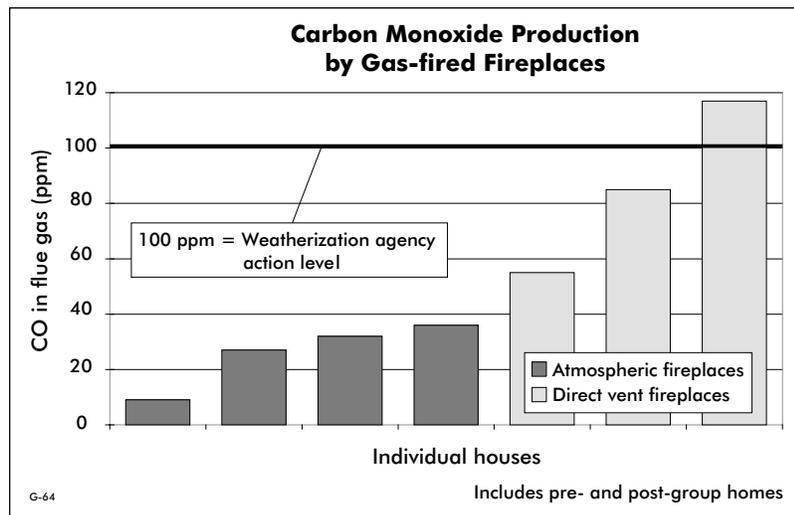
Under normal operating conditions, carbon monoxide production by most water heaters, furnaces and fireplaces was well below levels of concern. A few units stood out with higher carbon monoxide levels. Note that water heaters, furnaces and fireplaces are all vented to outdoors.

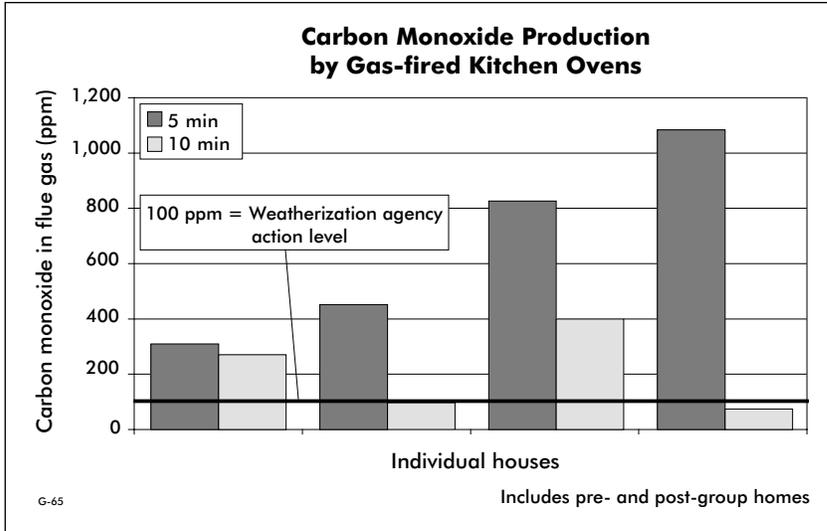
Carbon monoxide production by gas ovens was highest in the first few minutes of operation. After the burner had been on for 10 minutes, carbon monoxide levels had dropped significantly yet remained high enough to be a concern in three of four units. Note that all combustion products from gas ovens were exhausted into the houses and that only one in 11 study homes with gas ovens had a vented range hood.

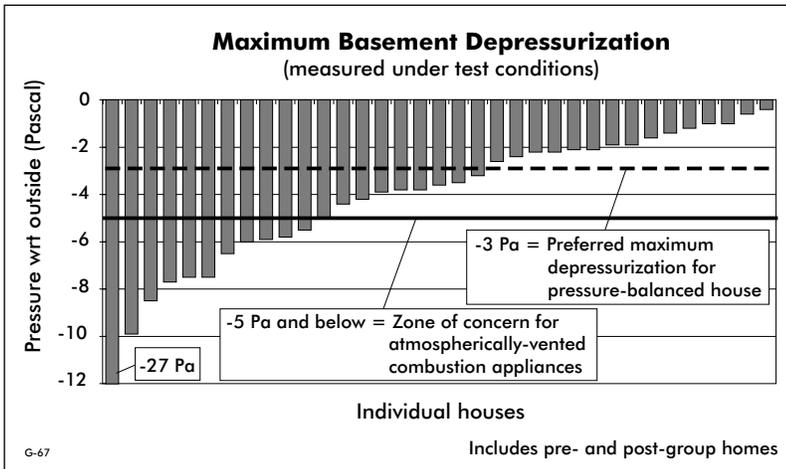
Under test conditions, all basements were depressurized with respect to outdoors. These negative pressures were of the same order of magnitude as the measured draft pressures in water heater and furnace flues, raising concerns about the abilities of these appliances to successfully remove combustion products from the house.

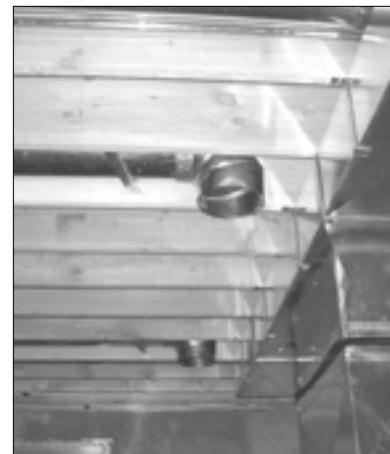
To help maintain a safe combustion environment, code requires large combustion air openings in the vicinity of atmospherically coupled combustion appliances. Testing showed that these ducts had very small beneficial effects on basement depressurization. In fact, when the wind blows in certain directions or when the exterior end terminates in an attic, ducts like these can drive the basement pressure more negative.

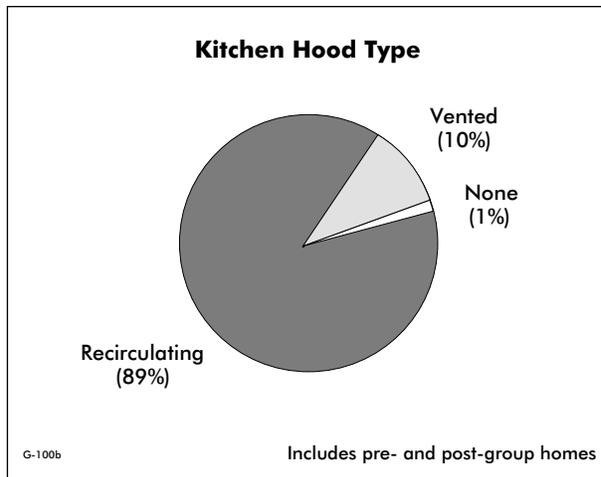
Few homes had vented hoods, even when gas ovens were present. A recirculating range hood coupled with an over-the-stove microwave oven was typical. This type of hood provided some degree of filtration but did not exhaust pollutants outdoors.

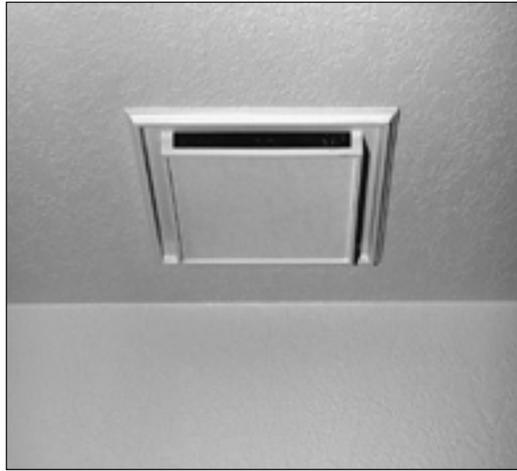
This metal flex duct material is easily crushed. Long 3" duct runs may constrict flow below rated performance.

A sharp turn at the fan's outlet serves as a large pressure drop that reduces flow.

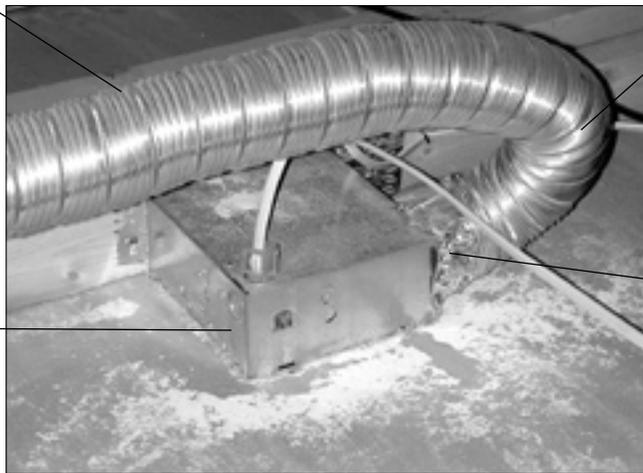
The fans were all low-cost units that garnered many noise complaints.

The tape that connected the duct to the fan housing had almost completely failed even before the attic was insulated.

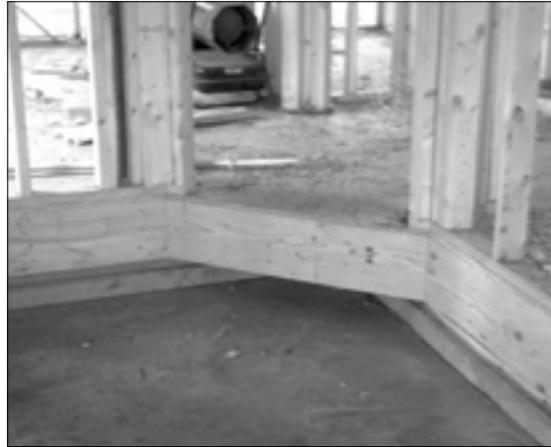
Many holes were observed between garages and houses, providing pathways for garage pollutants to move into the living spaces. This corner cantilever was liable to be a big leak because it was difficult to access to seal.

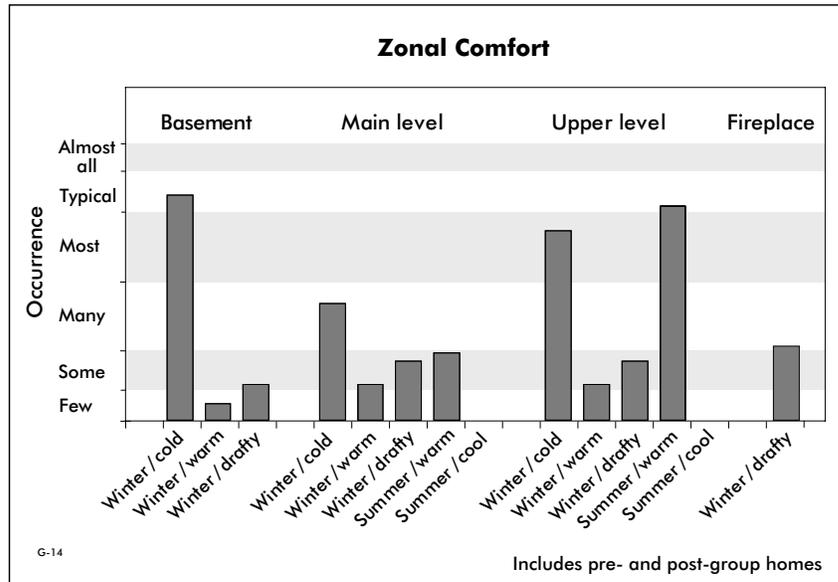
Comfort problems were reported on all levels of the study homes and in the vicinity of fireplaces.

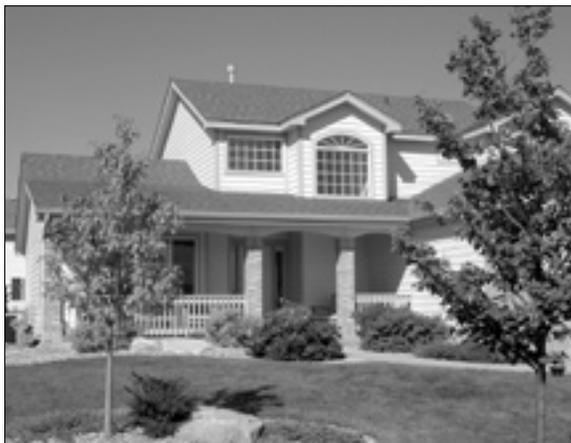
Rooms on the upper levels of two-story homes were often reported to be cool in winter and/or too warm in summer (even in air-conditioned homes).

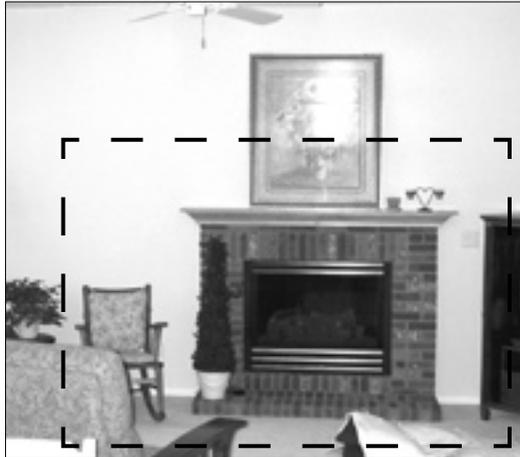
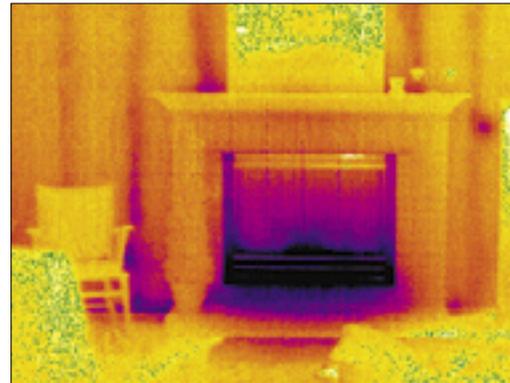
The owners of this house complained about drafts that made their living room uncomfortably cold. The infrared photo (right) shows the cold air that leaked around the fireplace unit. (This was a direct-vent fireplace, so there were no leaks between the room and the vent; all leakage was due to an incomplete air barrier in the cavity enclosing the unit.)

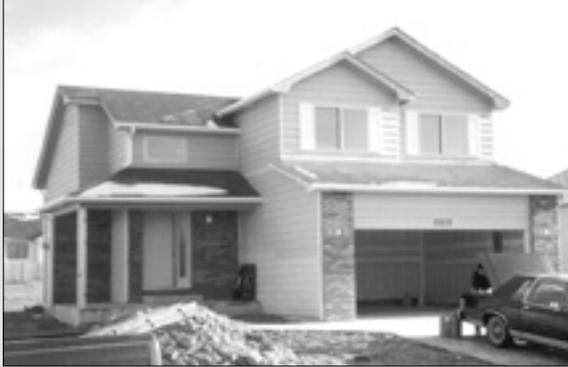
Living spaces extended over garages in half of the study homes.

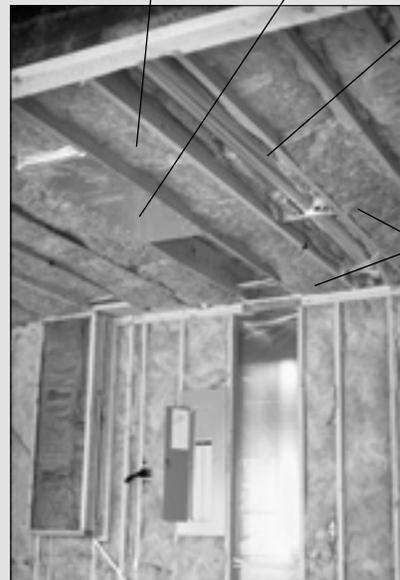
No insulation at return duct
 Six-inch thick, R-19 insulation supported insecurely against the subfloor in a deeper cavity
 Insulation difficult to install effectively around ductwork

Insulation has drooped away from floor above, leaving air space between them.

Flaws in floors built over garages contributed to poor comfort in living spaces above.

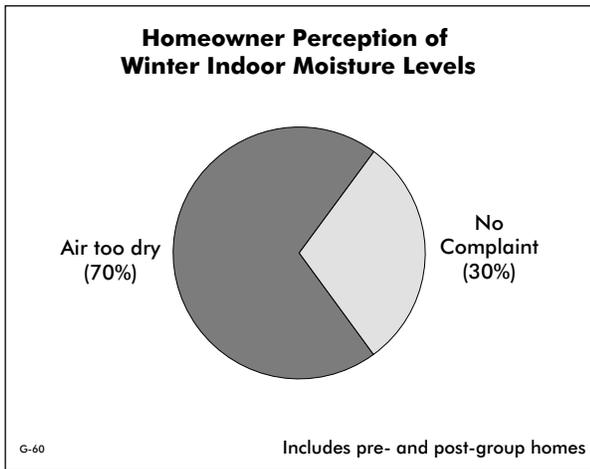
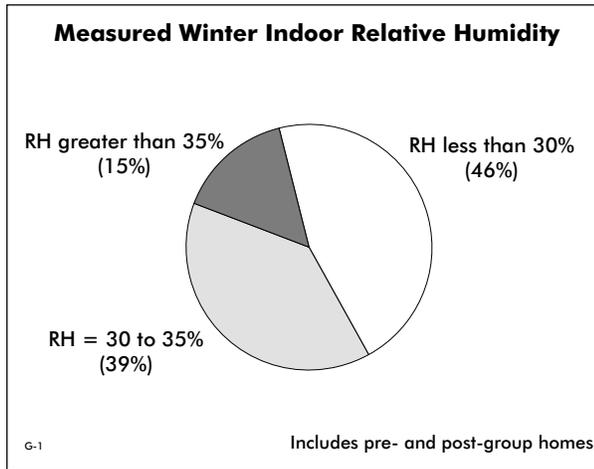
Dry indoor air during the winter was a common comfort complaint, borne out by humidity measurements.

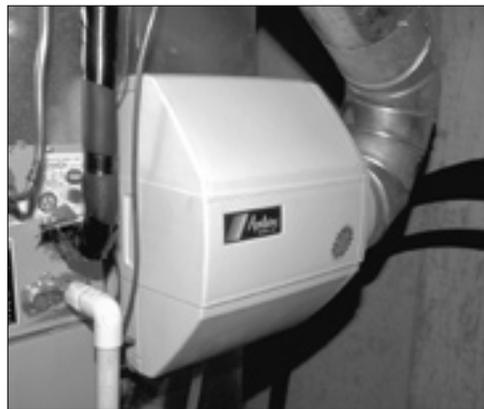
Humidifiers were present in 64% of the study homes. Most of these were central units located at the furnace, some were central, freestanding units, while others were smaller room units. Even in homes with humidifiers, dry winter air was a common complaint.

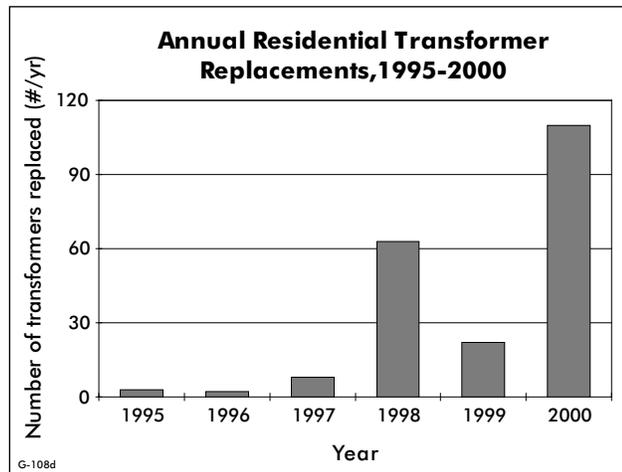
The graph shows the number of Fort Collins Utilities residential distribution transformers replaced each summer, beginning in 1995, due to overloading. Prior to 1998, a few transformers failed every summer, but the number was so small that it was not viewed as a significant issue. In the relatively hot summer of 1998, though, more than 60 transformers failed. Since then, the number

Larger homes and the increasing prevalence of residential air conditioning have caused the need to replace many distribution transformers since 1998. In response, Fort Collins Utilities increased transformer sizing criteria in 2001.

of failed transformers has remained high, varying in response to climate extremes.

Fort Collins Utilities staff responsible for planning and maintaining the electric distribution system attribute the increase in number of transformer replacements to a combination of larger homes with more electrical loads and the increasing prevalence of central AC. They believe—and the correlation with temperature supports—that AC is the largest factor.

Second, a program was established to preemptively replace transformers in neighborhoods with large AC loads with larger transformers, if loading indicators suggest the existing transformers are at risk of failure. Both changes have increased the cost of delivering power.

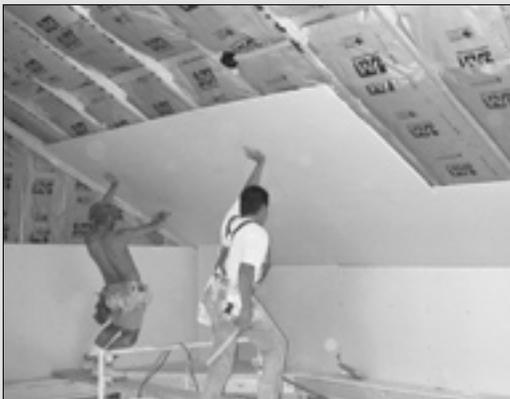
Wallboard represents the separation between the finish materials and the components and systems that determine how the house performs.

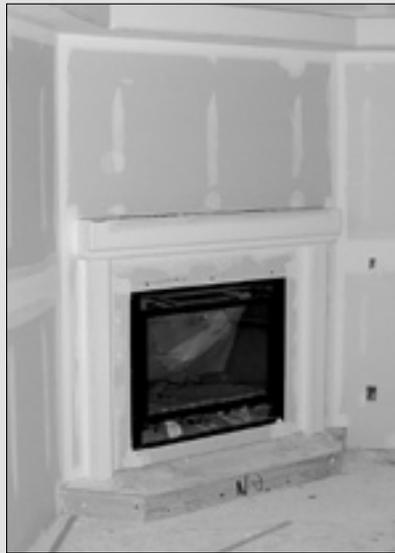
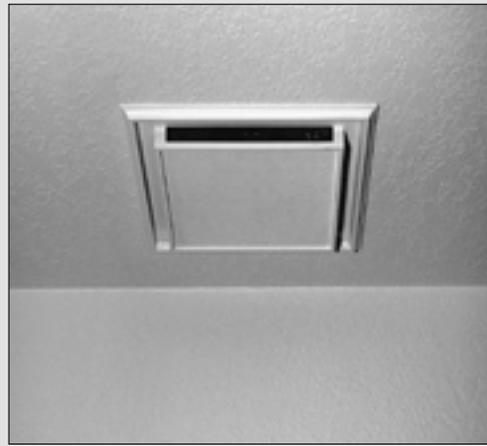
Many things are literally invisible behind the wallboard in a finished home: most of the framing, air sealing, wiring, plumbing, ductwork and insulation. For example, there is no way to see whether the insulation and air barrier were properly installed behind the fireplace or whether the bath fans were effectively vented.

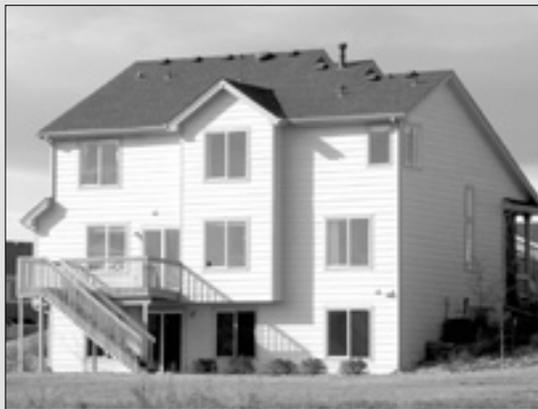
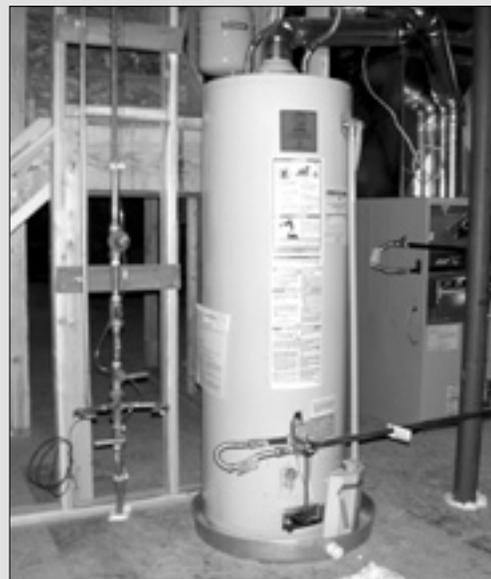
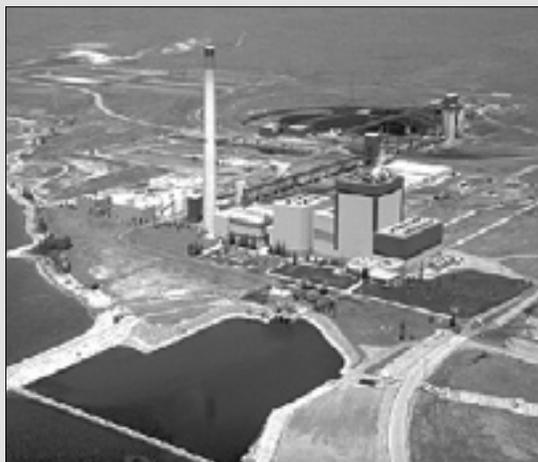
Many other aspects that are not hidden also receive little consideration in the purchase process. For example, little thought goes toward the type or solar orientation of windows, architectural features that need special attention, the efficiency or combustion safety of the water heater, or the impacts of design and construction decisions on the region's power supply needs.
